**CITY OF MELROSE**  
**APPROPRIATIONS & OVERSIGHT COMMITTEE**  
**AGENDA • MARCH 3, 2022**

Melrose has engaged Gale Associates, Inc. (Gale) to provide evaluation and design services to identify and address ongoing water infiltration at various locations in the building, improve daylight control within the auditorium clerestory windows, and general weathering and deterioration of various exterior building envelope components. As part of the evaluation, Gale has performed a leak audit, a visual observations of the building's exterior components and observed exploratory test cuts at roof, wall, and stair elements, performed by contractors, to better understand the general construction of the building. This evaluation report documents our observations, findings, and opinions on potential repair and replacement options.

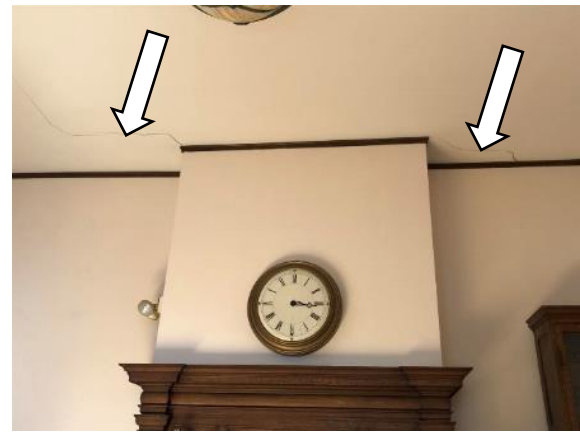
**Image 4:** Cracks in the ceiling at the south portion

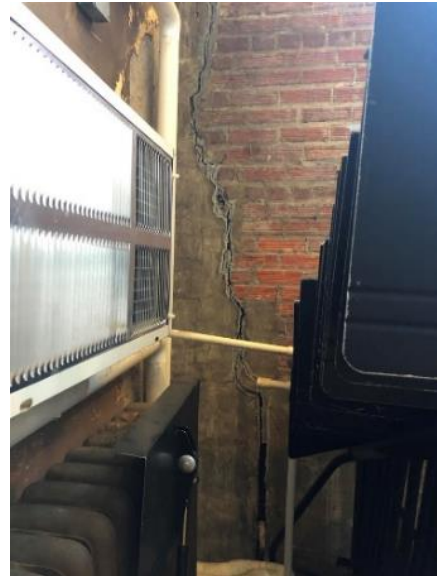
**Image 14:** Crack at the expansion joint at the Addition within the rear storage room

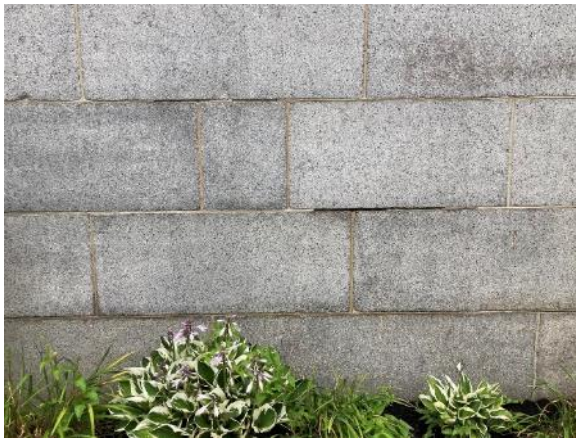
**Image 15:** Typical mortar condition within the granite; patchwork of missing mortar and mortar repairs

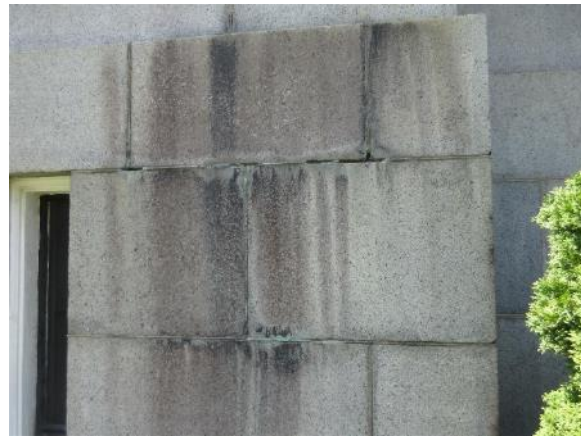
**Image 16:** Typical staining and deteriorated mortar within the granite at the front elevation

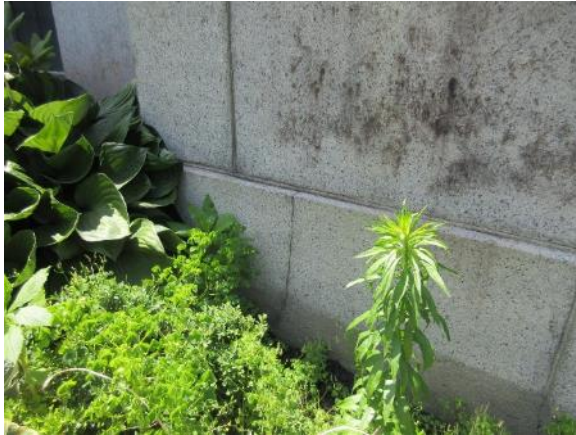
**Image 17:** Crack within a granite block at the front elevation near the foundation

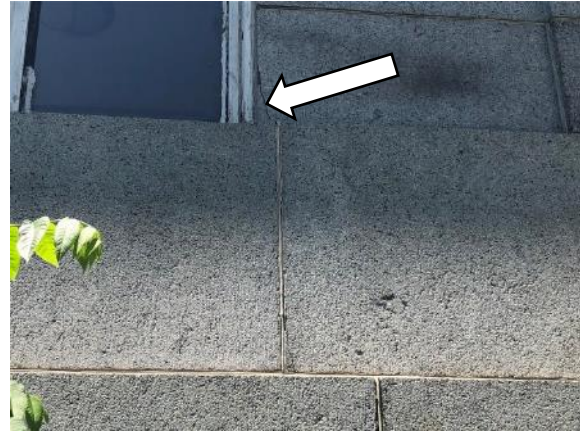
**Image 18:** Step crack (arrow) originating from a window in the front elevation

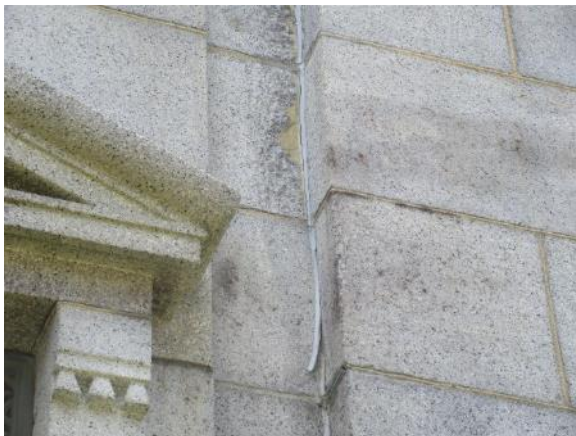
**Image 19:** Failed sealant around the perimeter of a recess in the granite facade

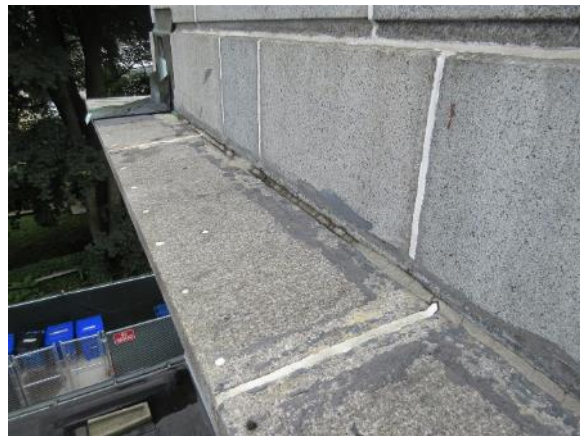
**Image 20:** Sealant repairs at the granite ledge on the west side of the North Wing

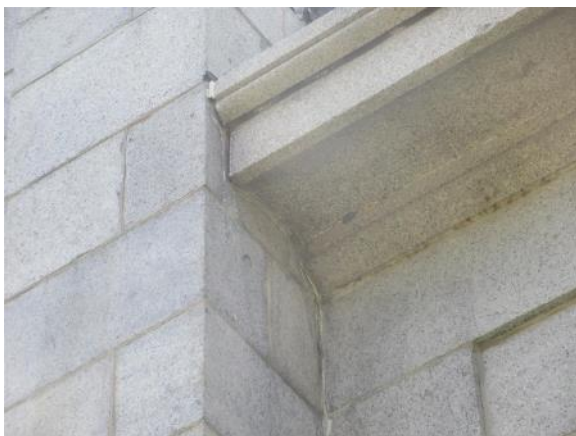
**Image 21:** Typical deteriorated sealant at the termination of the ledge at the rising walls

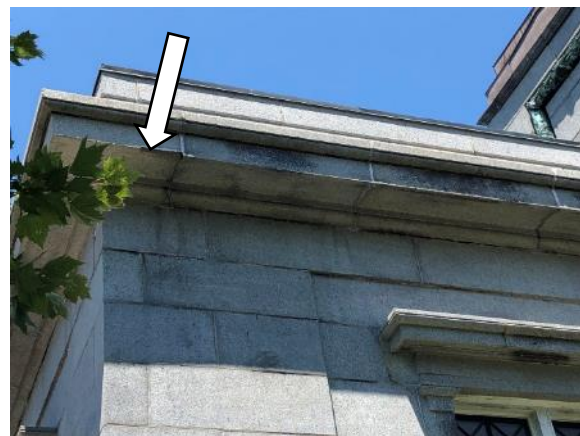
**Image 22:** Spalled ledge stone (arrow), as well as staining on the ledges and previous sealant repairs at the mortar joints

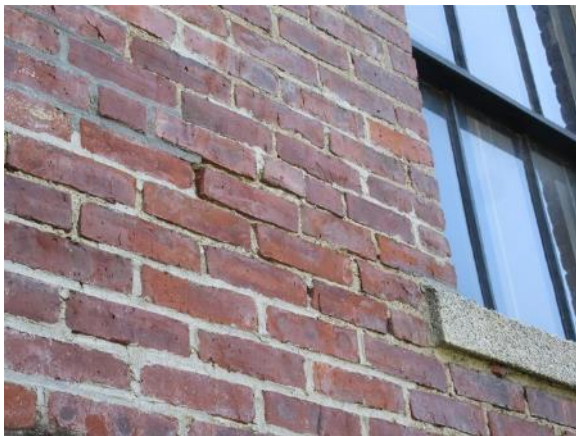
**Image 23:** Typical mortar condition within the brick masonry at the Addition

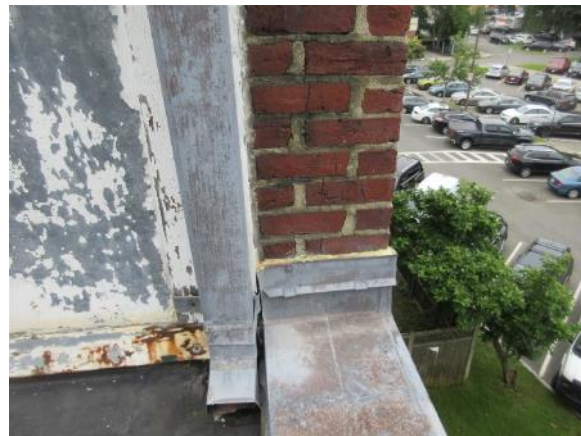
**Image 24:** Cracked brick and deteriorated mortar the brick parapet rising walls

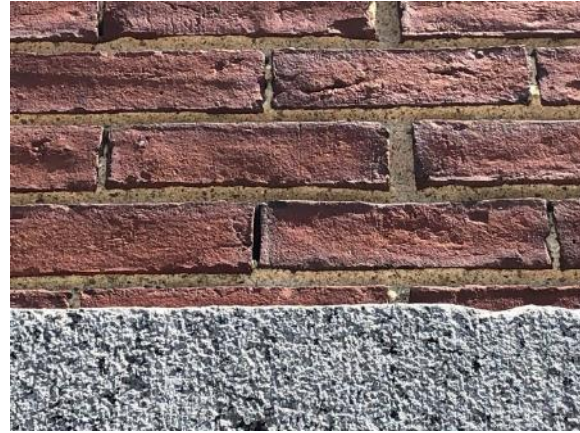
**Image 26:** Typical deteriorated and missing mortar joints at the brick inset areas at the original building

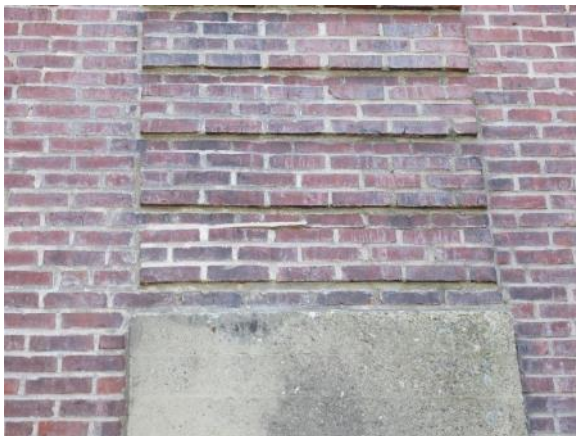
**Image 27:** Deterioration of mortar wash above the brick quoins

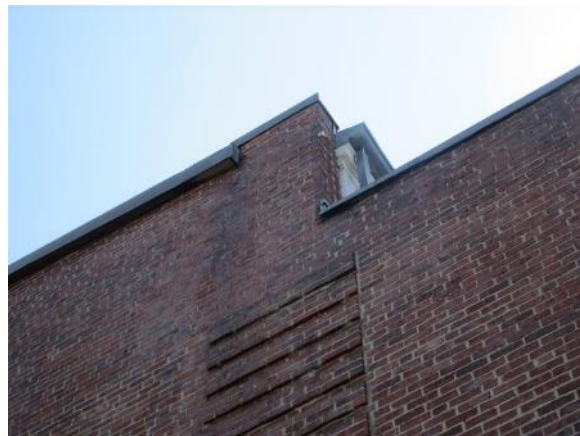
**Image 28:** Staining on brick masonry appearing to originate from the roof flashing

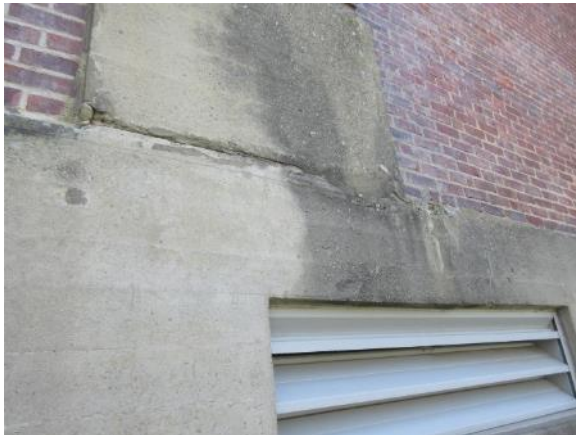
**Image 29:** Spalling and cracking in the concrete at the Addition

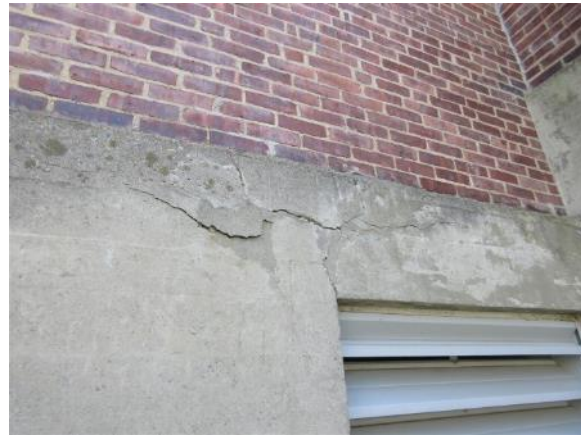
**Image 30:** Large crack above a louver at the Addition

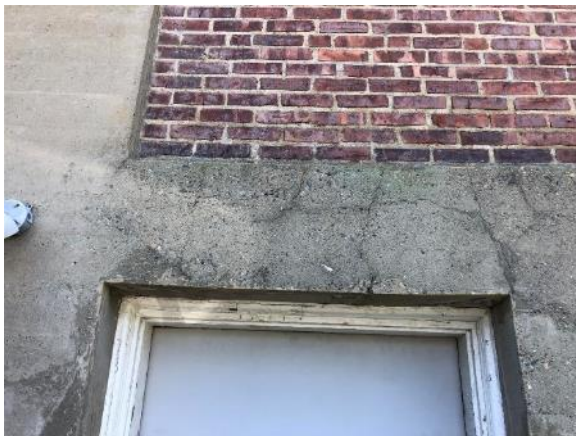
**Image 31:** Network of small cracks above the basement door at the Addition

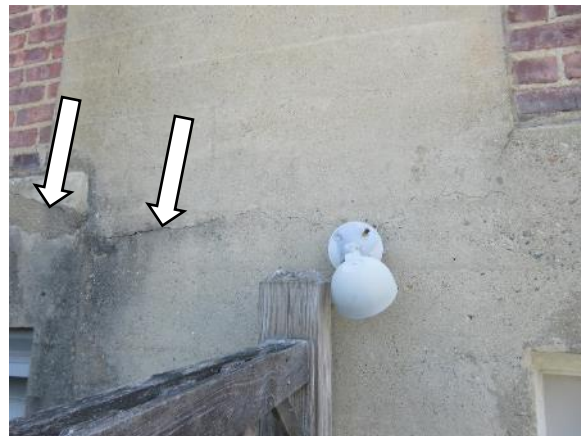
**Image 32:** Patched spall and cracking (arrows) occurring between portions of brick

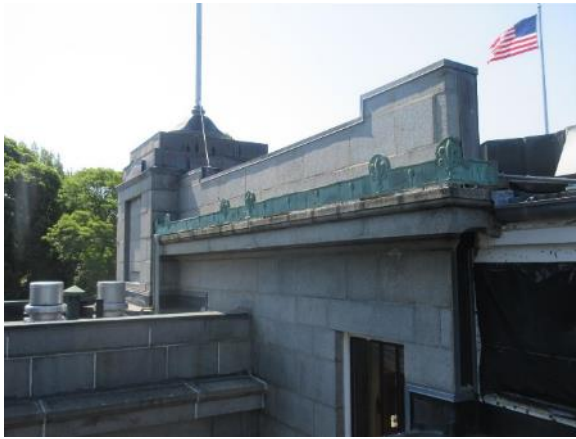
**Image 33:** Horizontal brass banding at Roof Area A parapet ledge on the North Elevation.

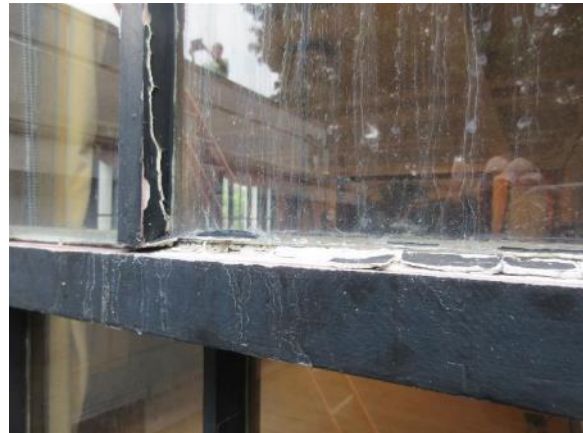
**Image 42:** Typical deteriorated glazing putty between the glass and the sash frame.

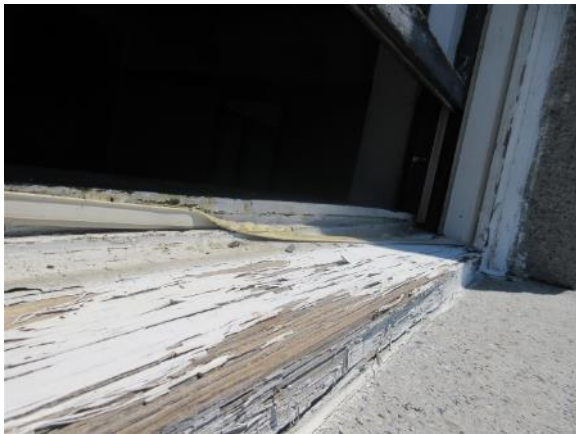
**Image 43:** Heavily deteriorated sills were noted at the windows with the 2<sup>nd</sup> story changing room on the south side of the building.

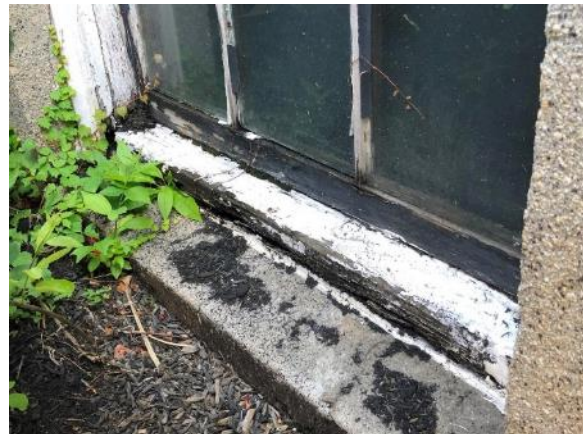
**Image 44:** Heavily deteriorated sill and window components at a rear basement window.

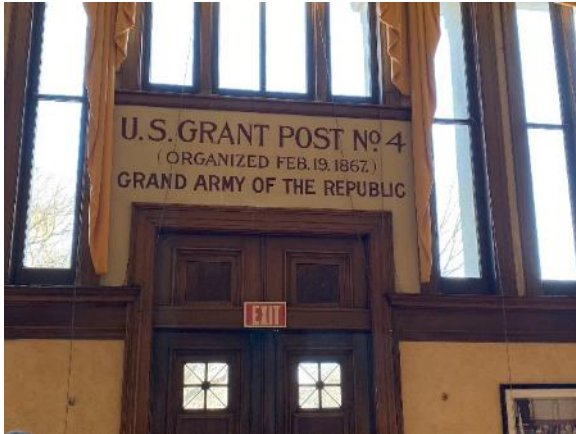
**Image 45:** Typical interior conditions for windows at the front of the building; this image taken at front entrance within the GAR Hall.

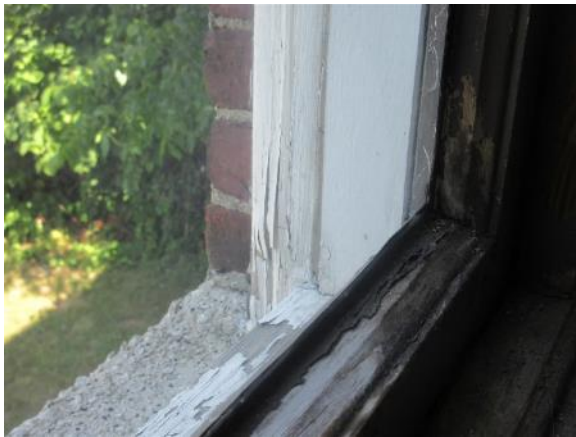
**Image 47:** Degraded interior paint and finishes on the windows and sills were noted at some locations.

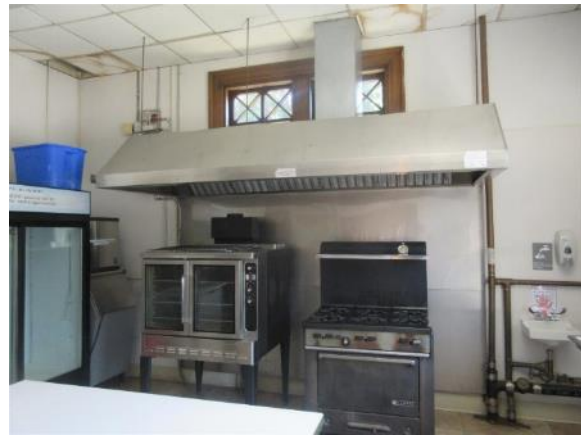
The hood is visible from the exterior as the window was not framed in. The vent will need to be disconnected to access the windows for repairs.

**Image 48:** The vent hood blocks access to a window within the kitchen; the hood is visible from the exterior.

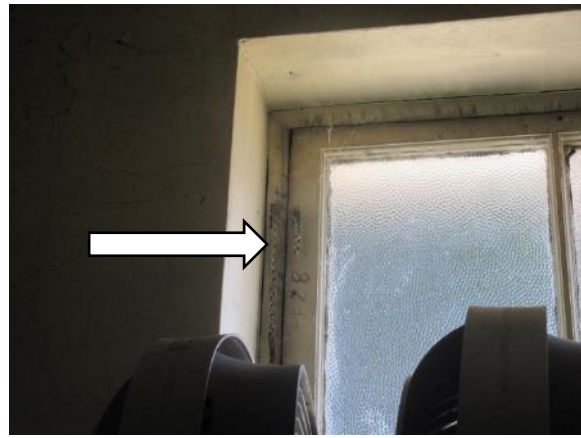
**Image 60:** Chain (arrow) for the operation of the basement hopper windows; arrow indicates a broken chain.

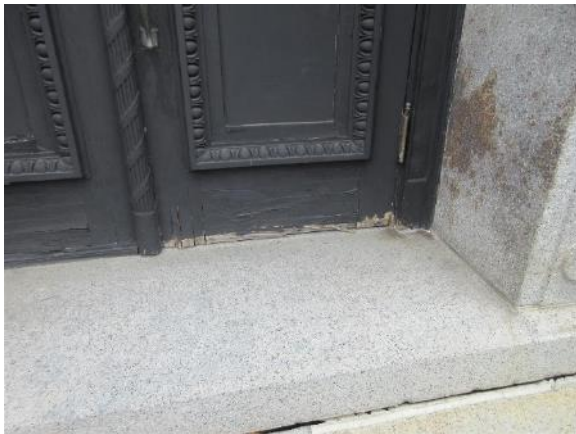
**Image 63:** Missing door sweep at one of the door leaves

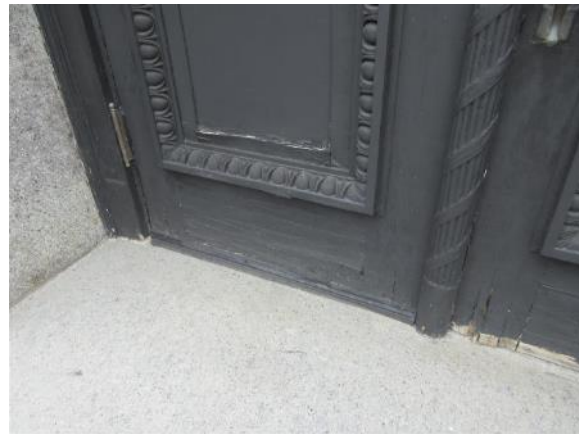
**Image 64:** Deteriorated wood elements noted at the base of the door leaves

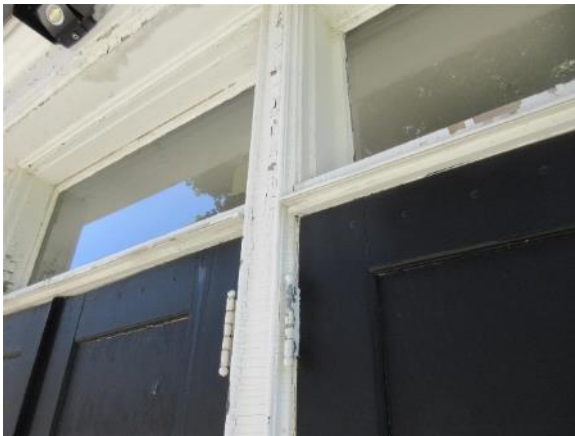
**Image 67:** Typical condition of the wood frame and trim with flaking and crazing paint observed throughout.

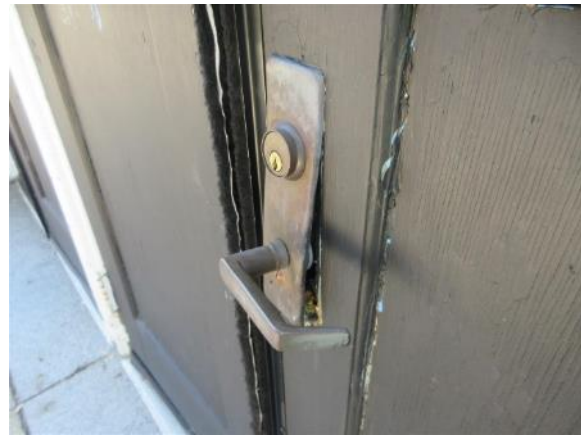
**Image 68:** Displaced and loose door handle was noted at one of the door leaves

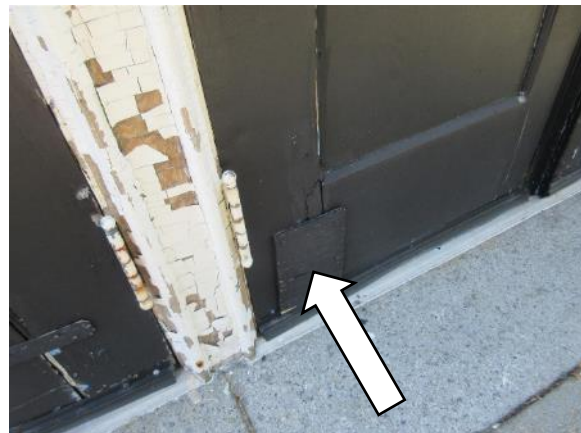
**Image 70:** Previous repairs (arrow) to the door leaves have become loose, and gaps were observed at multiple door leaves.

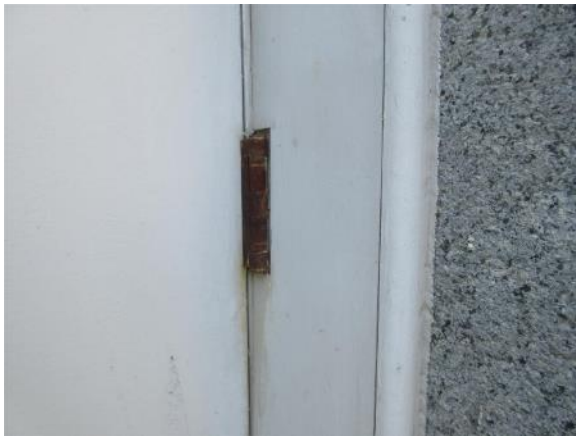
**Image 73:** Hinges at the doors were exposed to the exterior and were found to be rusted.

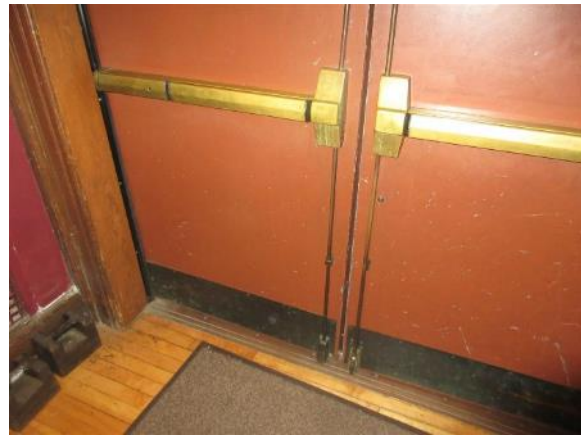
**Image 74:** Scratches in the paint were observed on the door leaves.

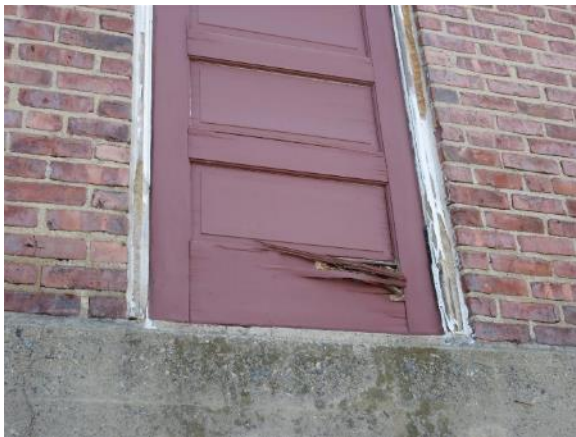
**Image 77:** Large chunks of the wood in the panels were found to be loose; the exterior brick moulding was found to be fraying and opening up.

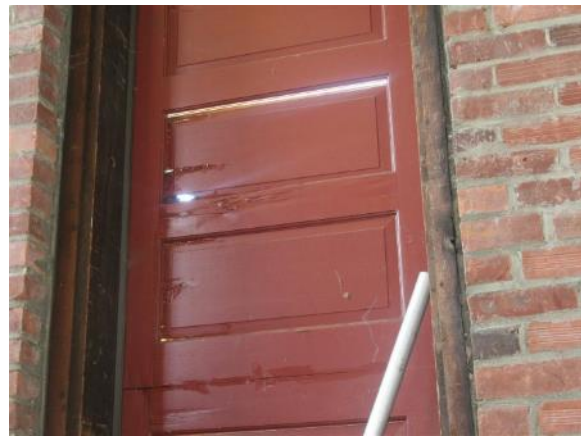
**Image 78:** Wood in the door panels was found to heavily deteriorated throughout, and gaps were observed in the door panels.

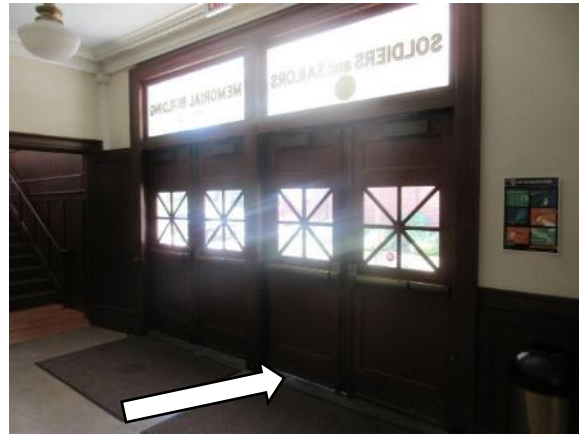
**Image 80:** Interior of the main entrance doors; daylight was observed coming from beneath one of the doors (arrow).

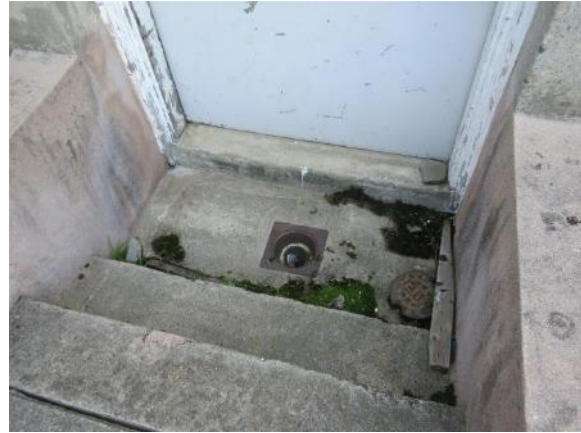
**Image 84:** Vegetative growth was observed on the landing in front of the door; a pipe possibly serving as a drain appeared to be clogged and non-functional

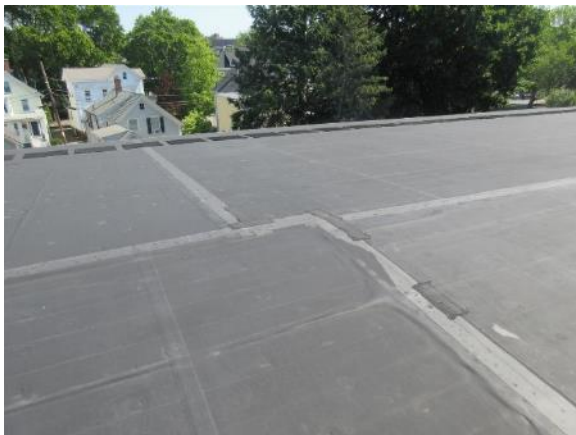
**Image 89:** Deteriorated seams were noted throughout the roof membranes on all roofs

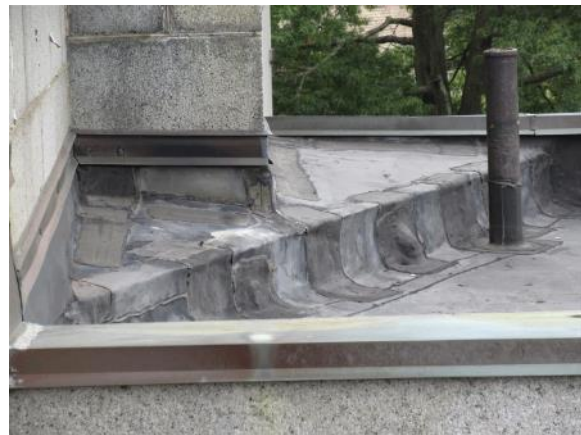
**Image 90:** Numerous patches were noted throughout the roof membranes on all roofs; this location on Roof Area E contained a particularly high number.

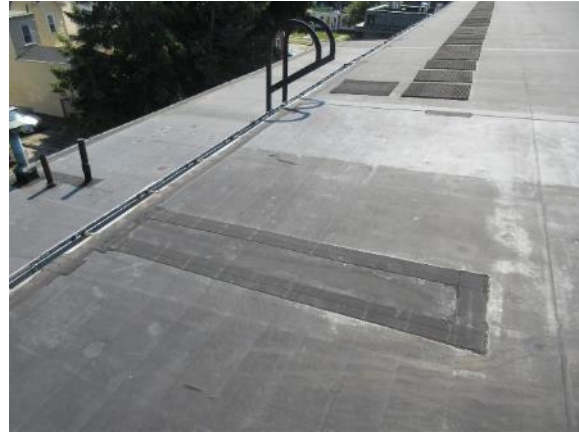
**Image 92:** Large patches with deteriorated seams were noted in numerous locations.

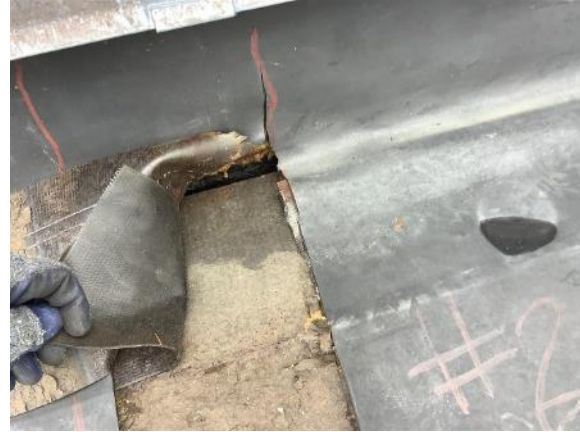
**Image 94:** Wet insulation observed at Test Cut #2.

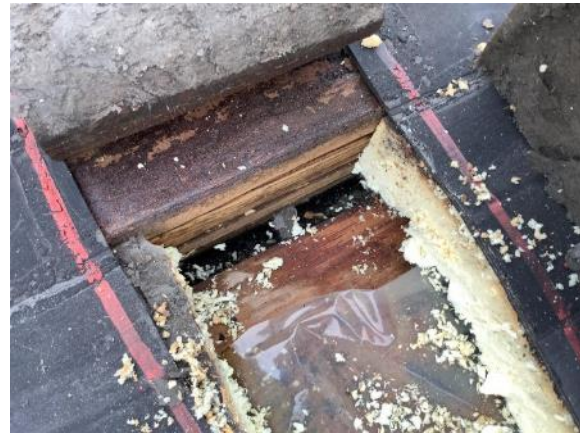
**Image 96:** Water staining observed on the roof deck at Test Cut #5.

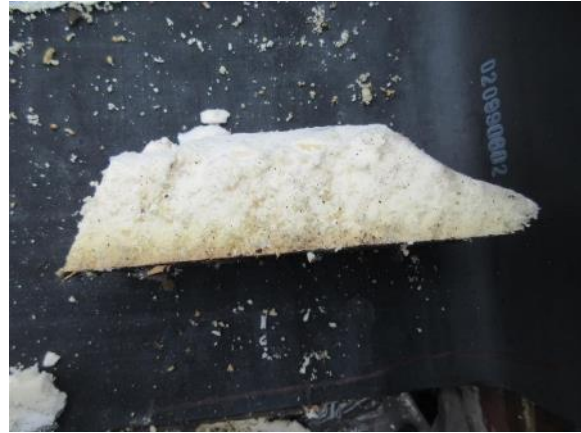
**Image 98:** Staining was observed in the top portion of the insulation at most test cut locations

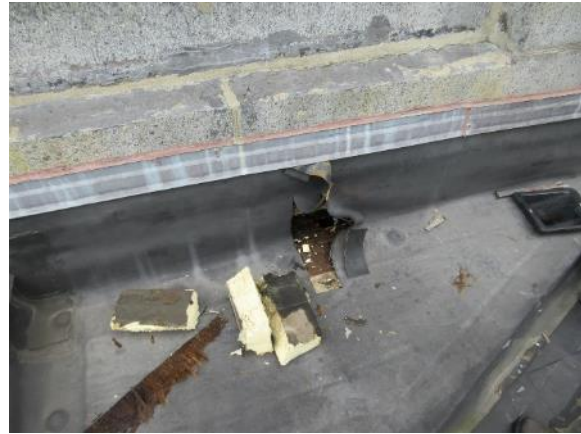
**Image 100:** Very wet plywood decking and corroded steel observed at Test Cut #14; refer to the Structural observations for more information.

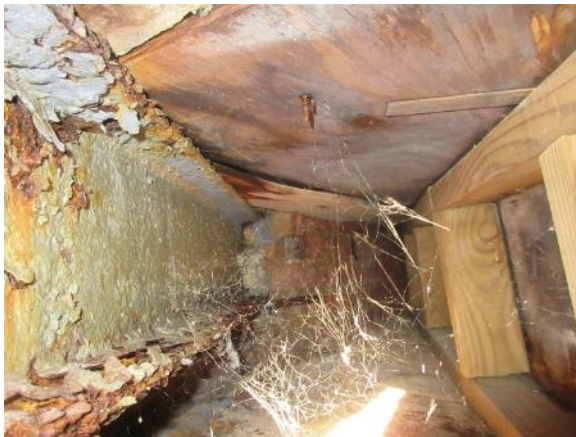
**Image 11:** View underneath the raised curb looking down along the diagonal member towards its embedment.

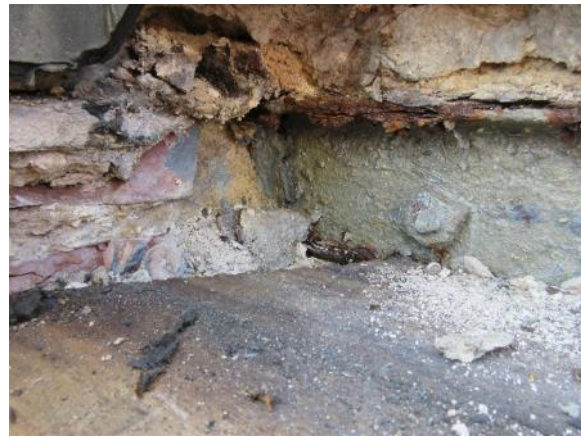
**Image 12:** The steel member was observed to be embedded in the parapet wall at the front of the building.

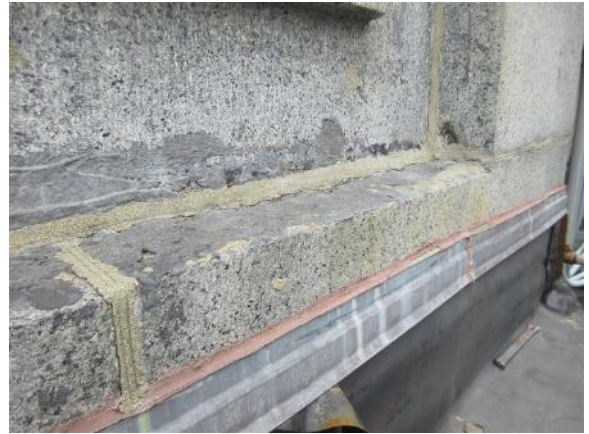
**Image 106:** Exposed ledge at inset area above Roof Area C without flashing or protection; roof-to-wall flashing detail utilizes a surface-mounted reglet flashing whose sealant was found to be deteriorated.

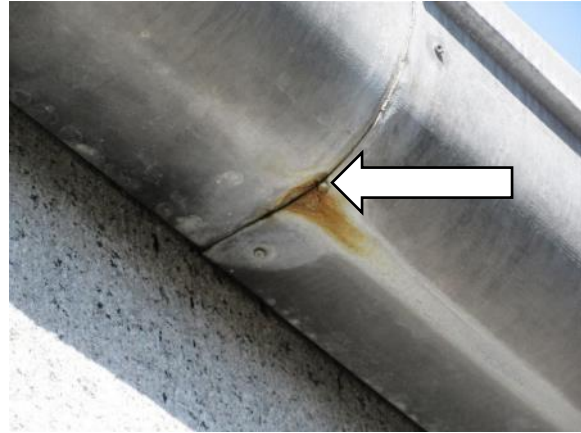
**Image 108:** Open seams in the gutters with active dripping water (arrow) were observed at multiple locations

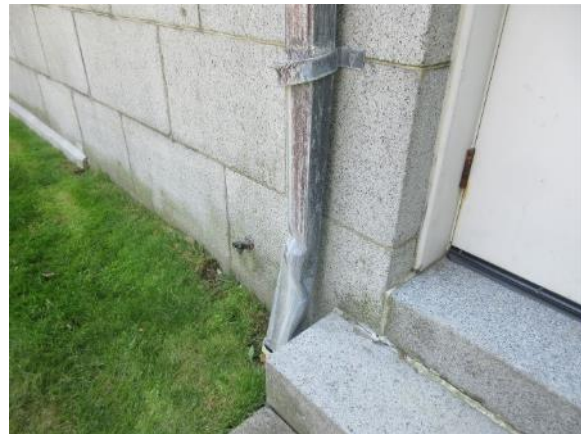
**Image 110:** The majority of the downspouts were found to be deflected at their lower portion near grade

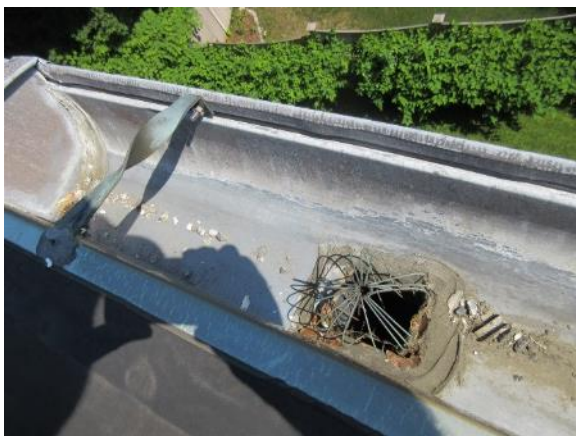
**Image 111:** Downspout strainers were found to be deflected and, in some cases, displaced from the downspout opening.

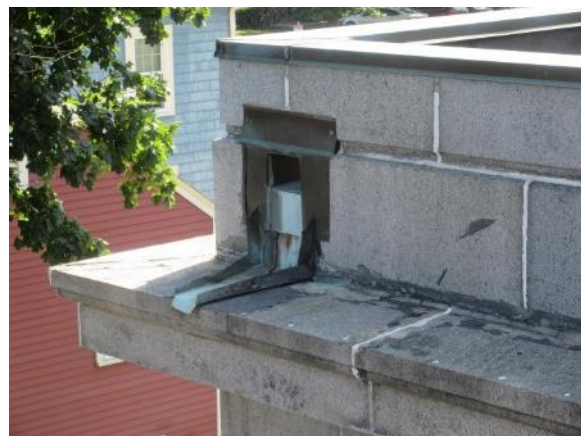
**Image 112:** Drainage from Roof Areas D and E are provided by scuppers that drain onto Roof Areas F and G; no downspouts are installed at these locations

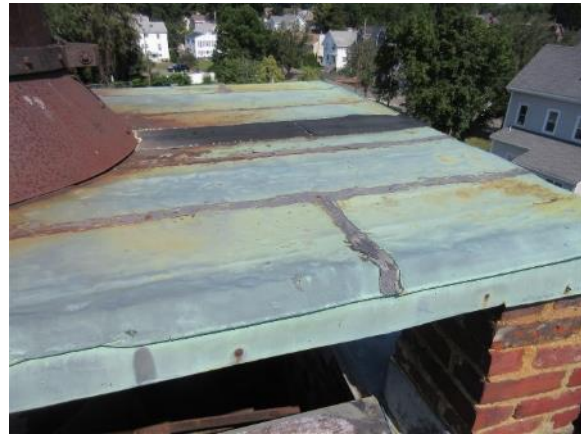
**Image 114:** Flat-seam copper panels were found to be pitted and deflected with seams repaired with sealant.

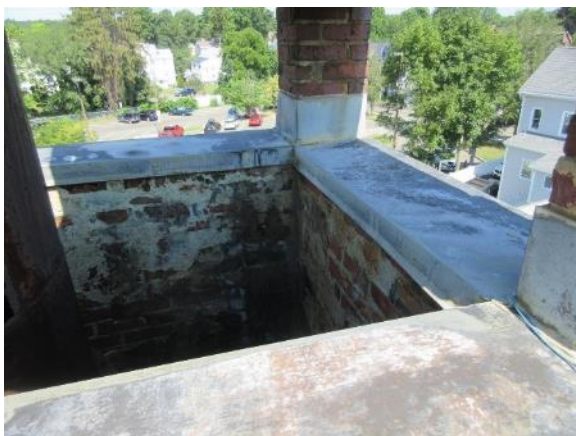
**Image 115:** The tops of brick walls below the cap are flashed with lead-coated copper flashing that appeared in fair condition.

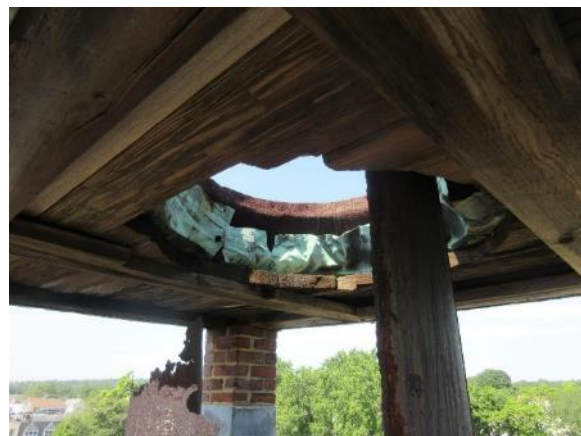
**Image 116:** Opening in the wood deck for the cast iron stack; the stack was found to be heavily rusted with portions missing.

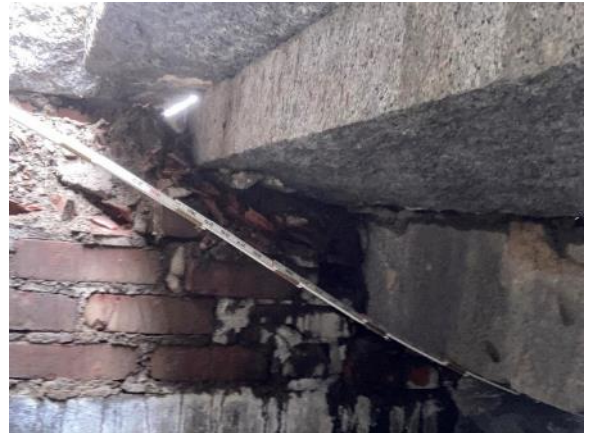
**Image 122:** View within the cavity looking towards a brick pier that supports the larger middle stair treads. Brick and mortar at this location was found to be loose and crumbled.

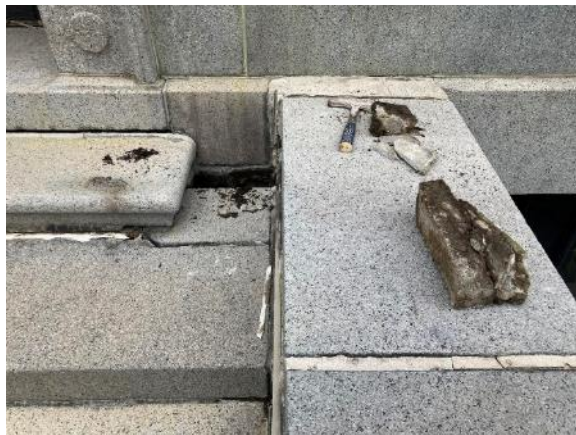
**Image 123:** A portion of grout was also removed at the large joint between the stair structure and the building.

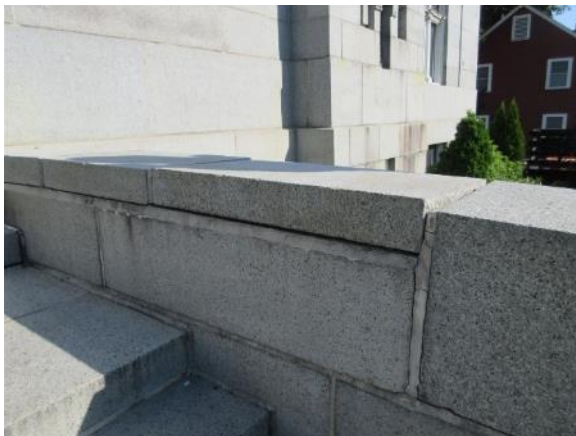
**Image 125:** Wing wall cap stones were found to be displaced with open mortar joints.

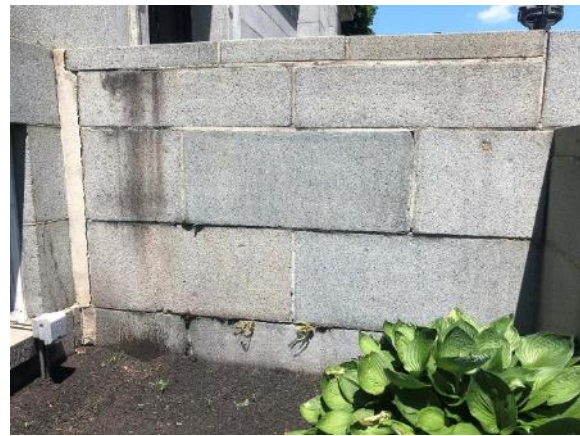
**Image 126:** Vegetative growth and open mortar joints were observed on the sides of the wing walls.

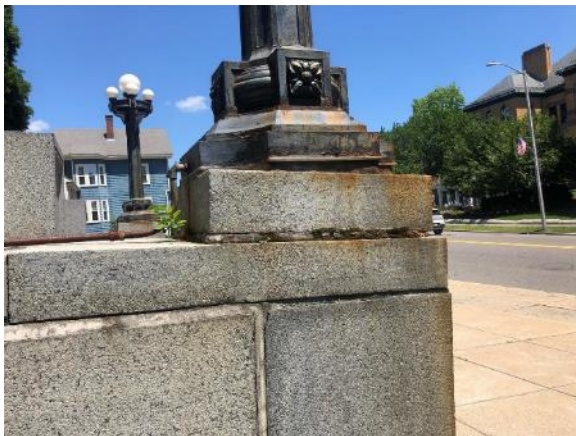
**Image 127:** The lamppost bases were stained and sit on a bed of deteriorated mortar.

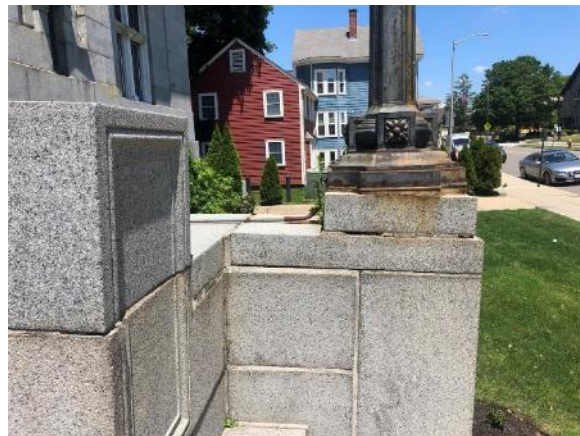
**Image 128:** The sloping of the entire stair structure can be observed below the lampposts, as the lampposts appeared to be installed plum, but sit on wedge-shaped grout bed on the sloping granite surface.
