**CITY OF MELROSE**  
**APPROPRIATIONS & OVERSIGHT COMMITTEE**  
**AGENDA • MARCH 3, 2022**

Melrose has engaged Gale Associates, Inc. (Gale) to provide evaluation and design services to identify and address ongoing water infiltration at various locations in the building, improve daylight control within the auditorium clerestory windows, and general weathering and deterioration of various exterior building envelope components. As part of the evaluation, Gale has performed a leak audit, a visual observations of the building's exterior components and observed exploratory test cuts at roof, wall, and stair elements, performed by contractors, to better understand the general construction of the building. This evaluation report documents our observations, findings, and opinions on potential repair and replacement options.

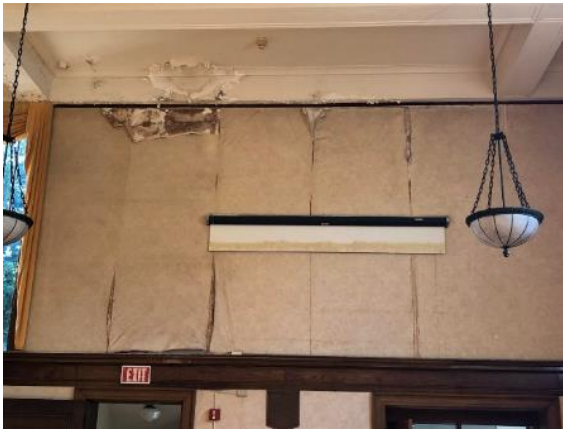
**Image 1:** Significantly peeling wallpaper and paint in the GAR Hall

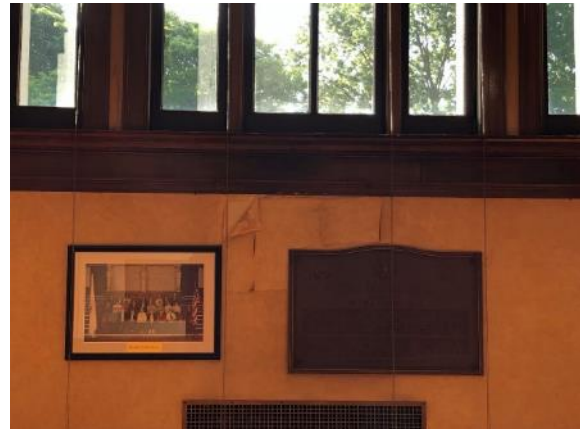
**Image 2:** Peeling wallpaper below front window sills

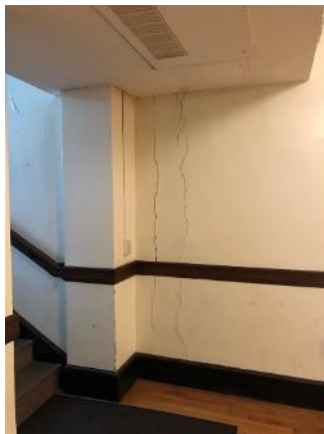
**Image 3:** Cracks in plaster within the basement immediately below the GAR Hall

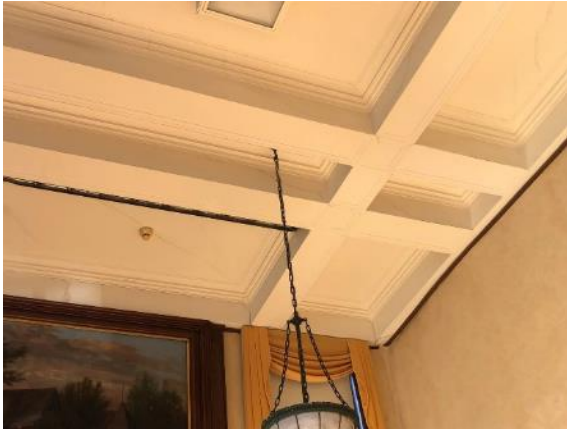
**Image 5:** Area of general plaster cracking in the GAR Hall ceiling (area is above Image 3)

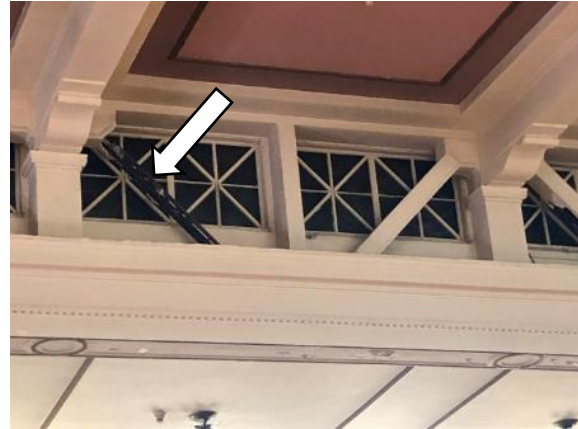
**Image 6:** Missing finishes on trusswork within the Auditorium

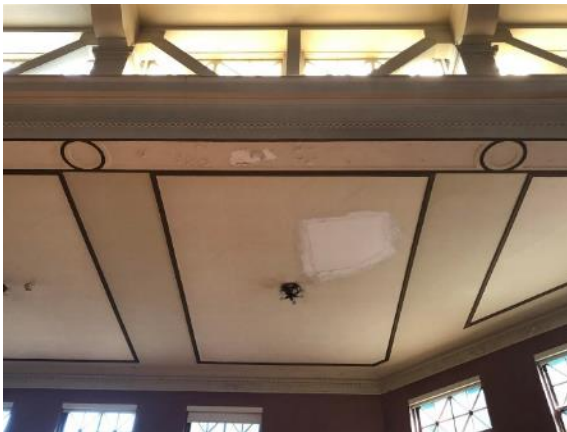
**Image 7:** Peeling paint and previous plaster repairs on the Auditorium ceiling

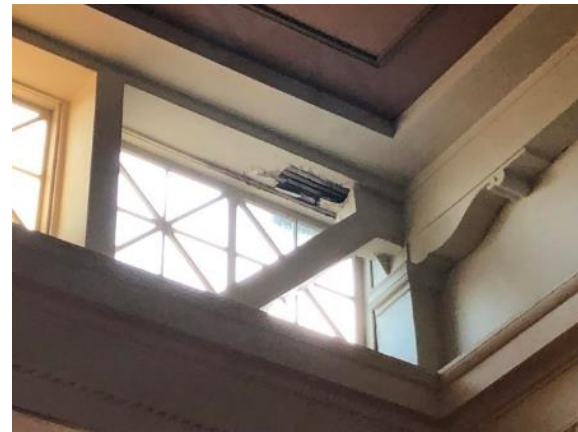
**Image 8:** Missing portions of plaster finishes at the upper clerestory windows

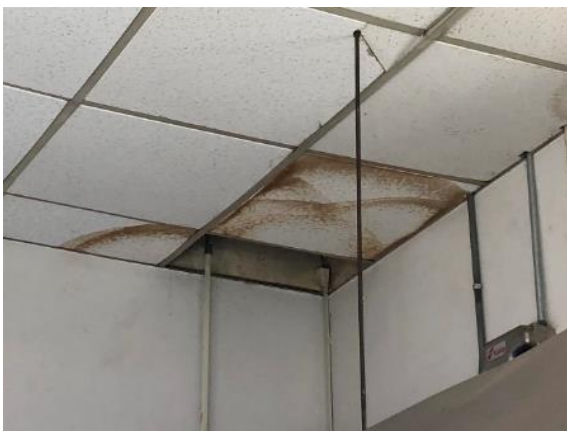
**Image 9:** Typical water staining on the ceiling tiles within the Kitchen

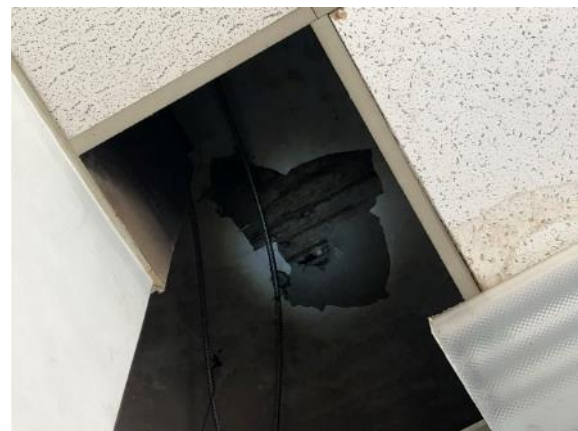
**Image 10:** Deteriorated plaster and lath ceiling above the suspended ceiling within the Kitchen

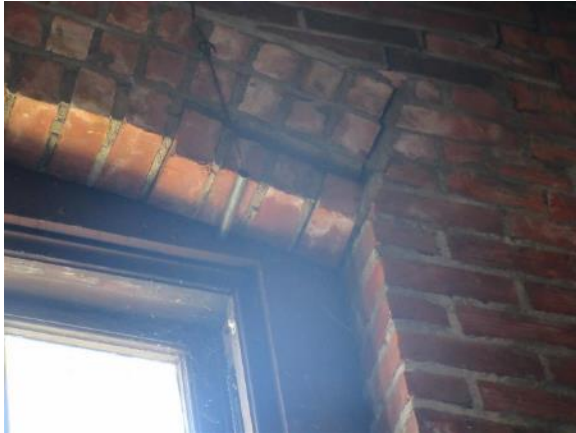
**Image 11:** Loose brick and delaminated mortar above the window in the rear storage room

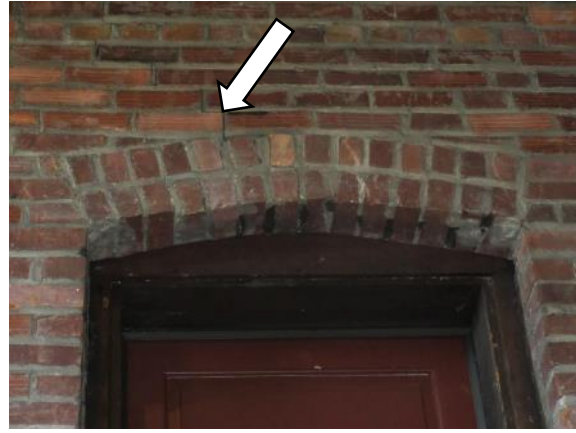
**Image 12:** Step crack (arrow) above organ access door in the rear storage room

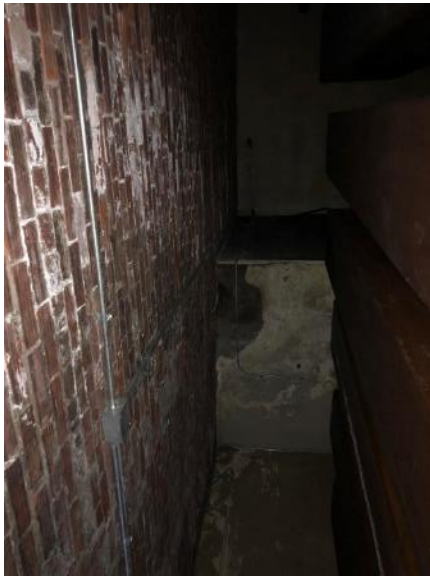
**Image 13:** Staining on plaster ceiling where the roof meets the rear brick wall

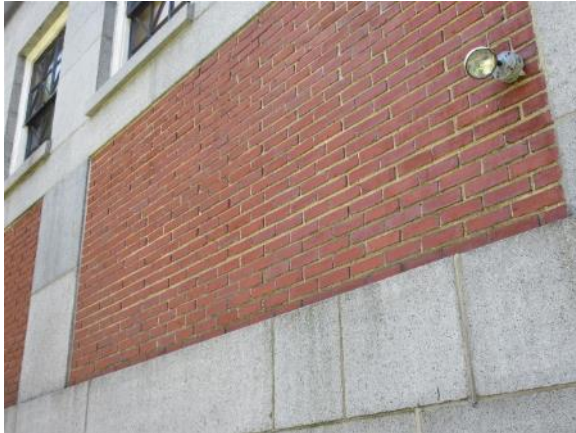
The original building features a series of rectangular brick infill areas on the North and South Elevations. While no cracked or spalled brick units were observed in these locations, the mortar joints appeared heavily deteriorated. In general, the mortar at these areas have been eroded approximately 3/8” from the face of the brick. Multiple head joints were found to be completely missing. Unlike the brick masonry at the Addition, no previous repointing efforts appear to have occurred in these areas.

**Image 25:** Typical brick inset area at the original building

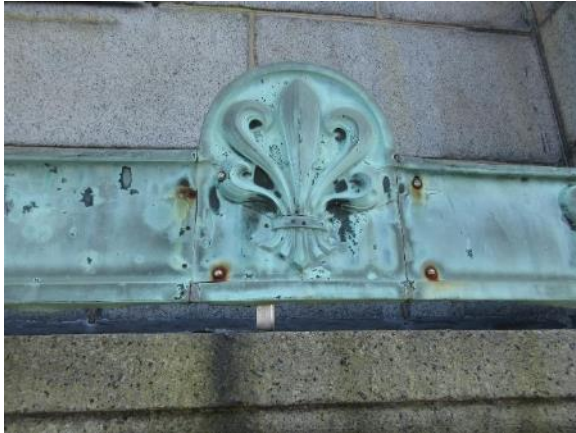
**Image 39:** Detail of a typical pendant in the horizontal banding. Rust was noted around fastener locations. Pitting and staining on the brass was observed throughout the banding.

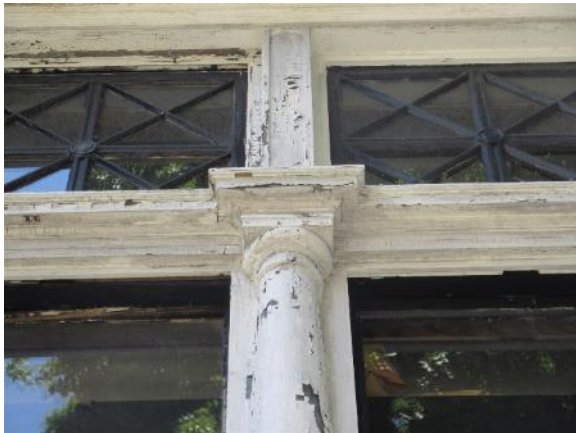
**Image 41:** Detail of a column capital as part of the window framing for Window Type D. Flaking paint is typical for all windows.

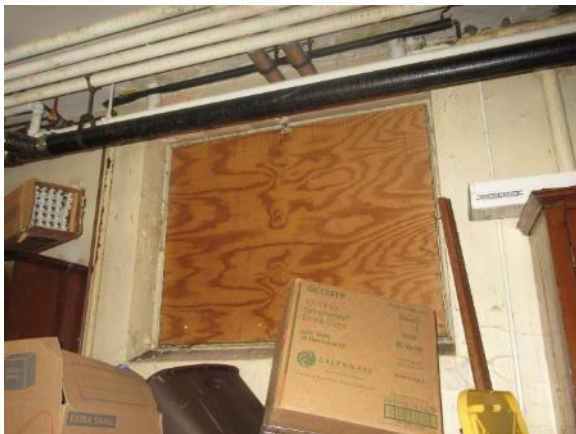
**Image 49:** Typical installation of a plywood blank-off panel on the interior; this image taken within the basement storage room at the northeast corner of the building.

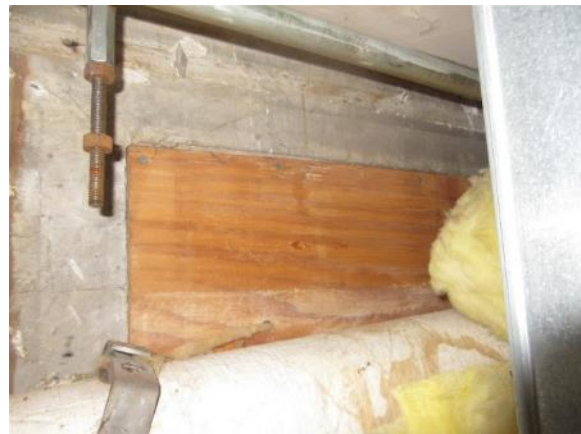
**Image 50:** Window concealed behind newer bathroom wall construction, also blanked-off on the interior with a plywood panel.

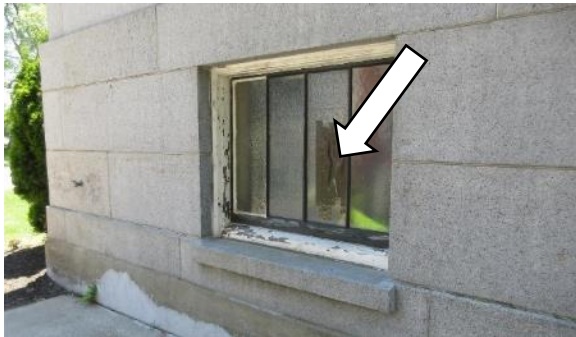
**Image 51:** Broken glazing covered with tape (arrow) at the basement window on the North Elevation

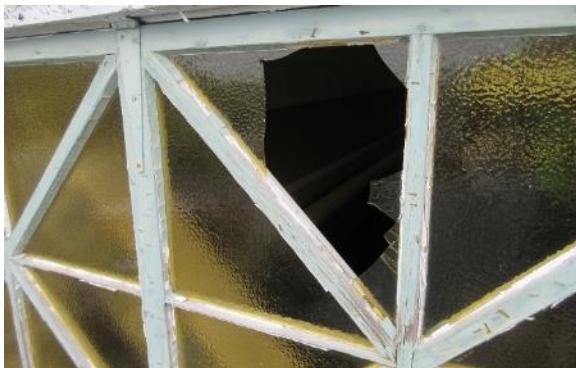
The majority of the glazing throughout the building was found to be fair condition, but with three instances of cracked or broken glass observed at the time of the evaluation. Reports from the building staff indicated ongoing problems with broken glazing, particularly within the upper clerestory windows above the auditorium, where two of the broken panes were observed during this evaluation. The poor condition of the glazing compound and areas of missing glazing compound appears to contribute to the reported broken glass. Without proper glazing compound the glass is free to move and fall out of place onto the roof surface below. Other instance of broken glazing was observed at the front of the building on the North Elevation within a basement window, which had been sealed with tape at the time of the evaluation. Additionally, differences in the yellow/orange tint between different panes of glass suggest that glass replacement has occurred at different times in the past, with some panes appearing lighter orange and some with a green tint. Enough different hues and shades were observed that it is difficult to ascertain what the original color is, and the glass appears as a subtle mosaic of colors throughout.

**Image 53:** Broken glass observed in the upper clerestory windows at the time of the evaluation.

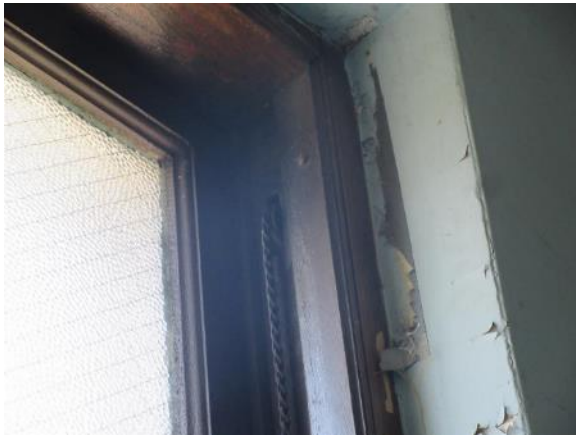
Window hardware such as locking mechanisms, hinges, pulleys, and handles consist of brass and generally appear to be in good condition, albeit weathered. Several double-hung windows were found to be missing their balance chain. At certain locations brass pulleys had been replaced with plastic covers. Multiple double-hung windows sashes do not have handle hardware to help raise the sash.

**Image 57:** Typical chain and pulley hardware at hung windows.

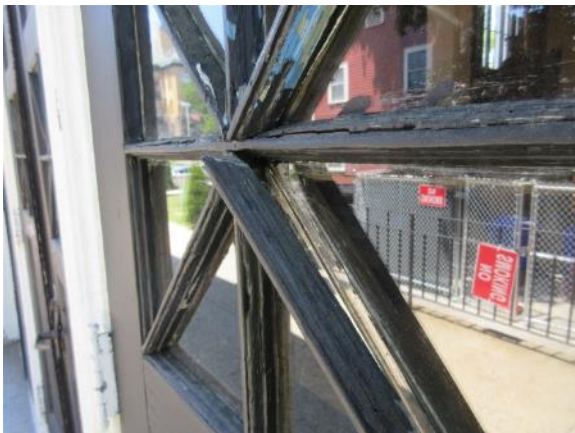
**Image 69:** Loose muntins and deteriorated glazing putty was noted throughout all of the doors.

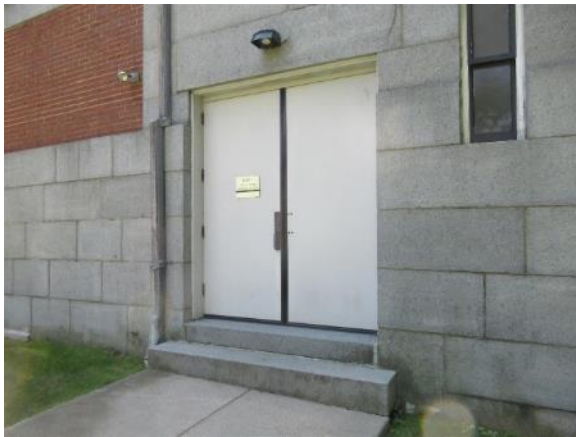
The side egress doors each consist of a pair of double hollow metal doors set in wood frames and are located on either side of the stage. These doors function primarily as egress doors with panic hardware installed on the interior but can also be operated on the exterior. The doorway on the South Elevation is used as an entrance by the Memorial Hall staff. The hollow metal doors and wood frames appeared to be good condition. Weatherstripping and door sweeps were observed to be installed and in good condition. Rust was observed on the door hinges that are exposed on the exterior. Minor paint defects and scratches were observed on the interior of the door leaves.

**Image 71:** Typical exterior of the auditorium side doors (Door 103)

1. Scraping, repairing, and painting the wood front entrance doors and metal side and rear doors in place.
2. Replacement of the wood North Lobby entrance doors with a pair of two (2) sets of wood-veneered, metal double doors, transom windows, and frame to match the configuration of the South Lobby entrance doors.
3. Replacement of the organ access door at the rear of the building with an operable fiber-reinforced plastic (FRP) door.

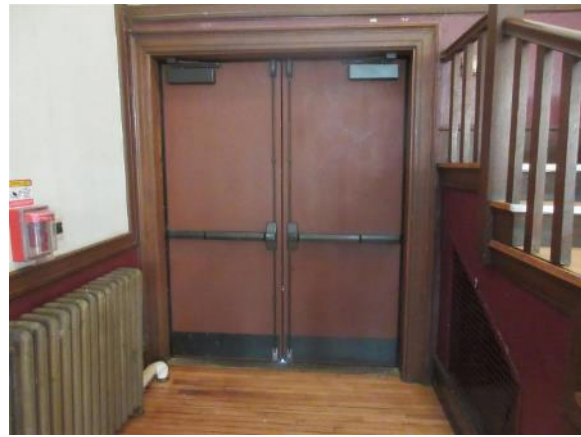
**Image 72:** Typical interior of the auditorium side doors (Door 103)

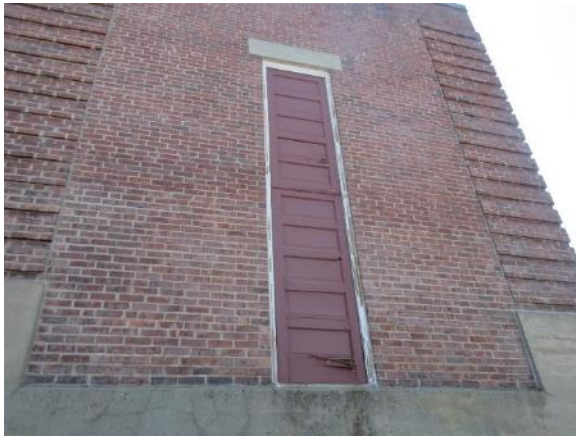
The rear of the building features a tall access door, reportedly utilized for replacing pipes for the organ located behind the stage. The door consists of a wood frame and wood panels set into the frame with no apparent operating mechanism or hinges. The wood paneling appears to consist of two separate panels with a meeting rail installed between them. The paneling is heavily deteriorated with large gaps appearing in the woodwork with daylight observed through the door from the interior. Large chunks of wood have split off from various rails in the paneling on the exterior. The wood door moulding on the exterior appears to consist of fibrous wood material, possibly medium density fiberboard (MDF), that is also heavily deteriorated with fibrous material exposed.

**Image 75:** Exterior of the organ access door.

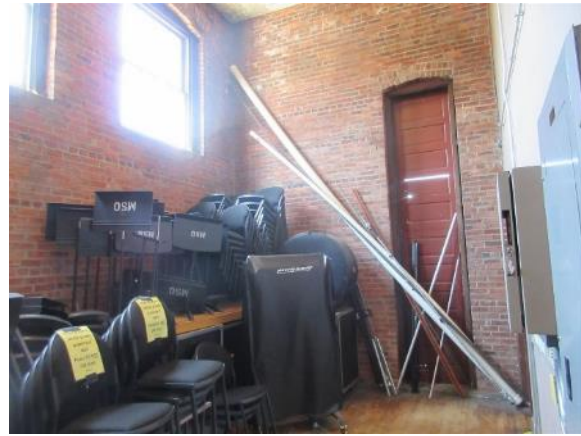
**Image 76:** Interior of the organ access door.

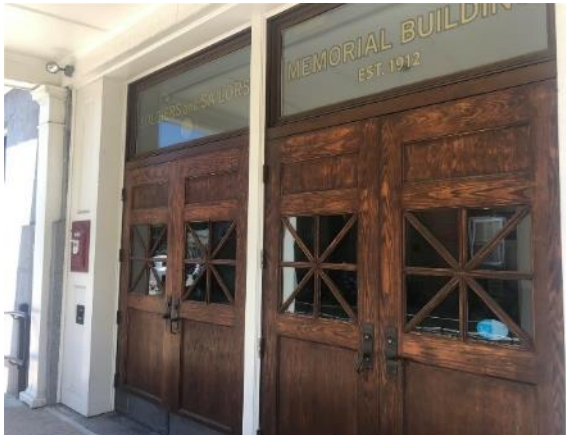
The main entrance doors were reported to have been replaced in a previous project reportedly in the late 1990s. These doors function as the primary public entrance to the building. They consist of (2) 6'-0" wide double door openings with wood paneling on either side and fixed transom glazing above. The doors and framing are in good condition and utilize insulated glazing units within vision lites in the door leaves and transom. Daylight could be observed coming through the interior beneath one of the door leaves, indicating the door sweep is not engaging with the floor.

**Image 79:** Exterior of the main entrance doors.

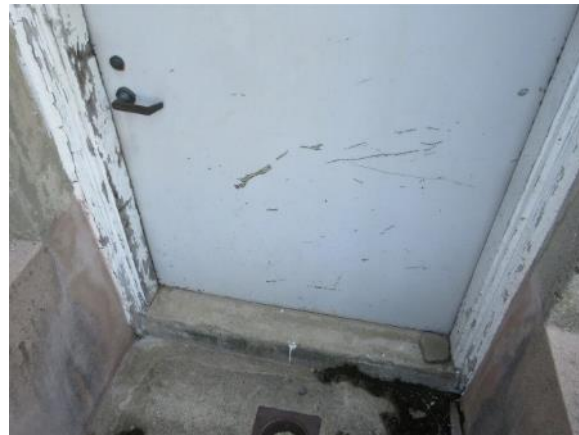
**Image 82:** Detail of the door trim and leaf exhibiting flaking and crazing paint and scratches in the paint on the door leaf.

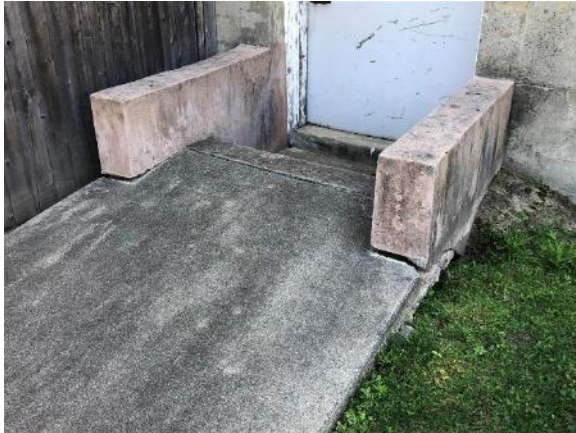
A small concrete stair with wing walls sits in front of the door also exhibiting signs of deterioration, with vegetative growth occurring at the landing in front of the door. The stair appears to be cracking and separating potentially due to erosion of the soil below the walkway and stair. In addition, the area drain at the bottom of the stair appears to be clogged and possibly non-functional.

**Image 83:** Condition of the stair in front of the door; the concrete path leading to the stair is beginning to separate from the stair structure; erosion of the fill beneath stair was noted

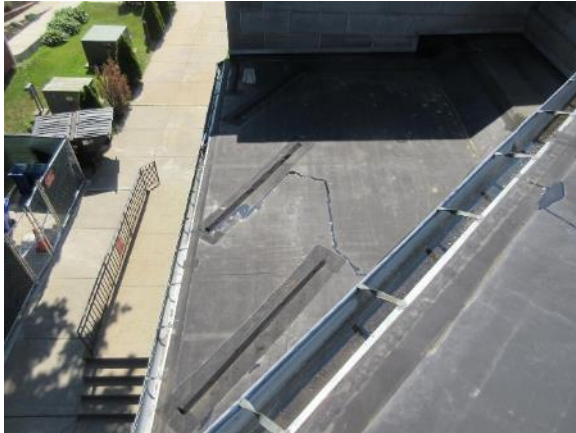
**Image 91:** Rain diverters installed on Roof Area F

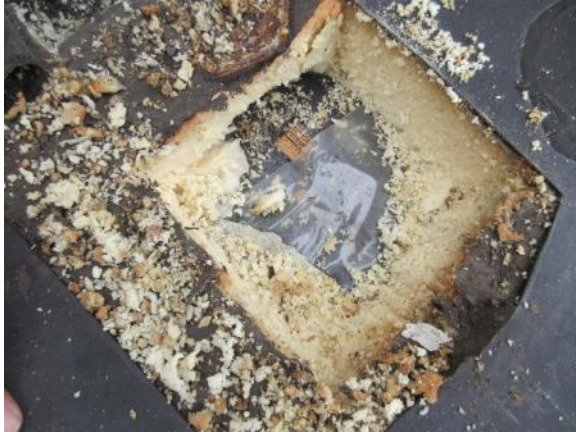
Aside from Test Cut 14, all test cuts revealed the presence of a vapor retarder. However, the vapor retarder was observed to be found to be unsealed and untaped, and in most instances the vapor retarder stopped short of the roof edge or did not extend up the full height of the roof thickness. In some cases, the vapor retarder was folded in on itself or crumpled at the test cut location.

**Image 93:** The plastic vapor retarder was not terminated at all perimeter test cut locations.

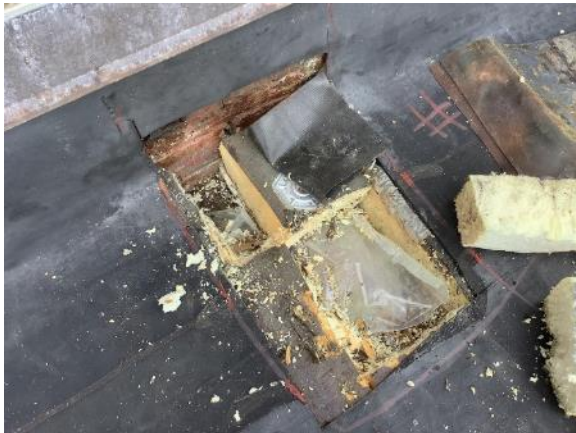
**Image 95:** Crumpled and unterminated vapor retarder at Test Cut #3.

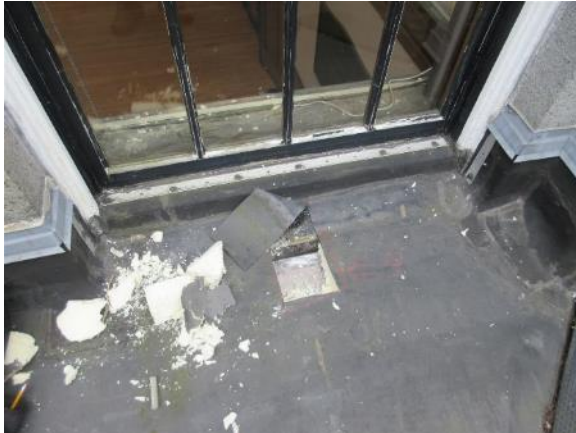
**Image 97:** Test Cut #8 performed at the sill of Window Type H. The roof membrane was found to be terminated on the window sill with a termination bar.

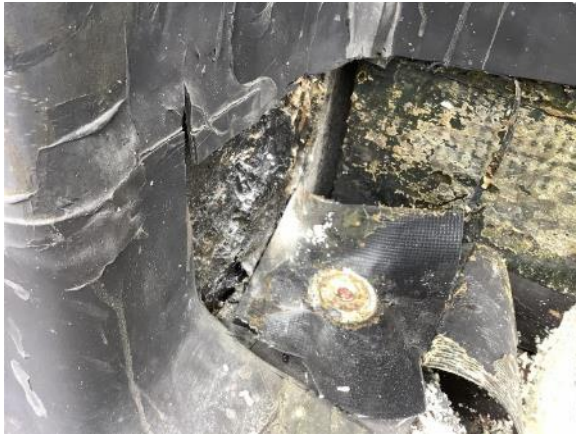
**Image 99:** A gap in the granite wall was observed at Test Cut #13.

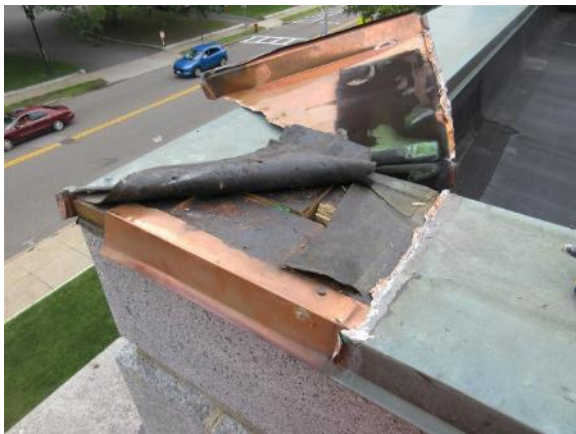
**Image 101:** Test Cut #15 was performed at the corner of Roof Area D to open the parapet cap

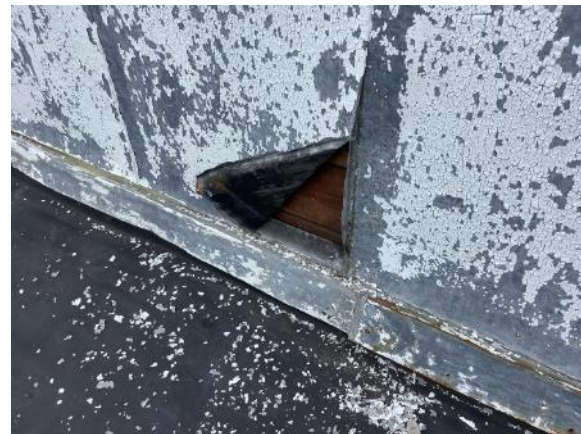
**Image 102:** A portion of the sheet metal siding was lifted open to reveal a wood back-up wall, which appeared to be in good condition.

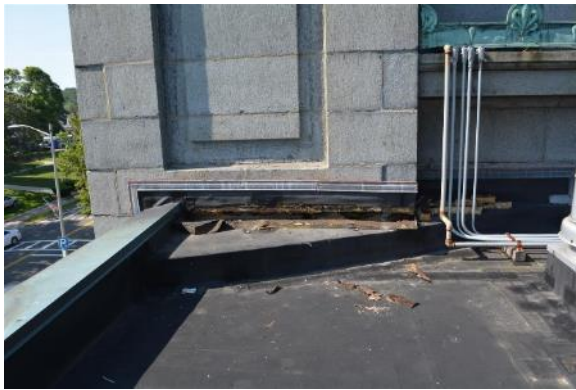
While observing Test Cut #14, wet plywood decking as well as deteriorated steel members supporting the granite blocks above was identified at the base of the flagpole tower on Roof Area D. Further exploration revealed a steel member and a diagonal steel member exhibited significant rusting and scaling of the steel. Similar exploratory work was performed at the opposite (south) wing of the building on Roof Area E, revealing similar conditions though the steel appeared more intact on the south side. The steel appeared to have been originally cast in a cementitious material. The cementitious material was wet and deteriorating. In both instances the diagonal beam is enclosed by a raised curb. At the south wing the curb was found to be clad with copper sheet metal under the EPDM membrane roofing.

**Image 11:** Location of steel exploration at Roof Area D at the base of the flagpole rising wall

1. Replacement of deteriorated steel beams supporting masonry at the flagpole towers at the north and south wings.

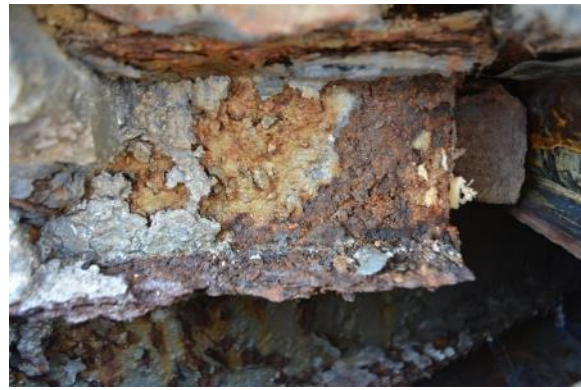
**Image 12:** The steel immediately below the masonry wall exhibited heavy rusting and portions flaking away

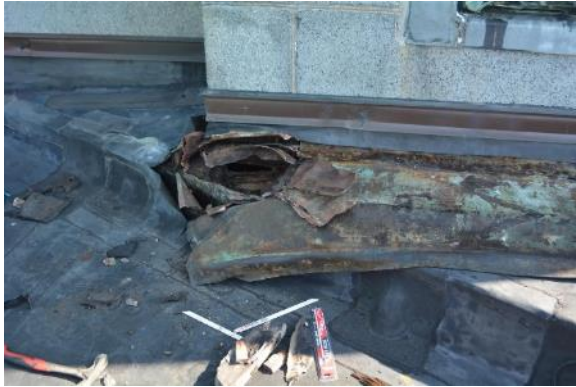
**Image 11:** Location of steel exploration at Roof Area E

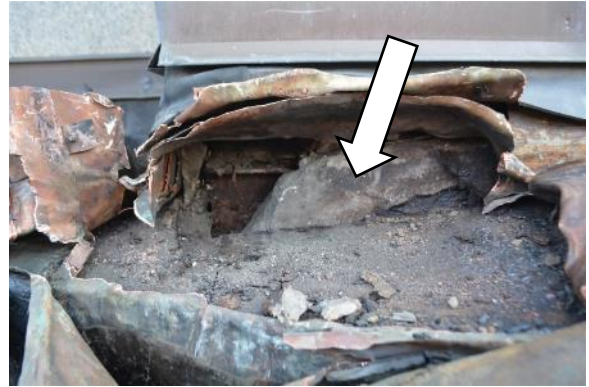
**Image 12:** Detail of the test cut showing the copper cladding and cementitious material (arrow) that coats the steel at this location

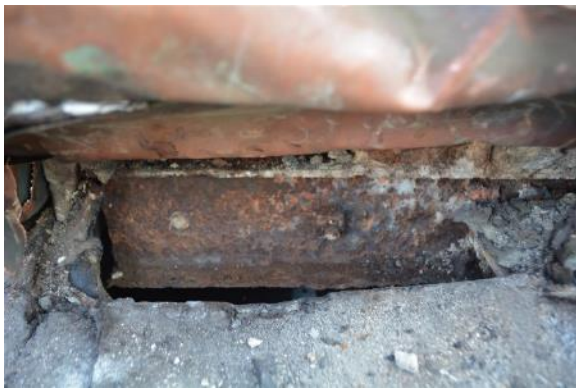
**Image 11:** The steel exposed at this location was found to be heavily rusted.

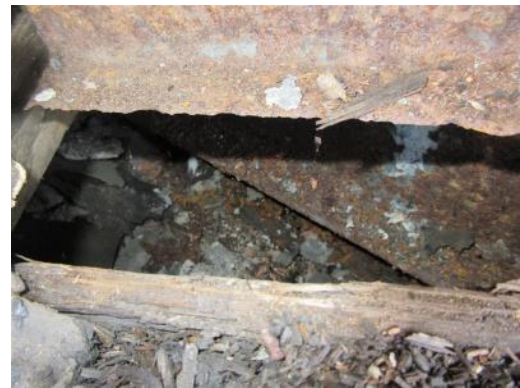
**Image 12:** The steel member was found to be supported on a diagonal steel member similar to Roof Area D.

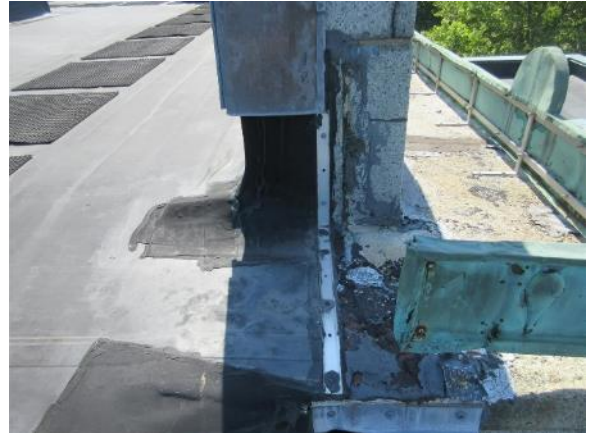
**Image 104:** Membrane terminated with an exposed termination bar at the transition to the granite ledges on Roof Area A.

1. Flashing repair around the perimeter of the roofs and membrane seam repairs to EPDM Roof Areas A, B, and C.
2. Removal and replacement of Roof Areas D, E, F, G, and H with single-ply PVC roofing.
3. Removal and replacement of all gutters and downspouts.
4. Removal of the existing chimney cap and four (4) brick piers down to the sill of the existing opening, and the installation of a new cap at that height.

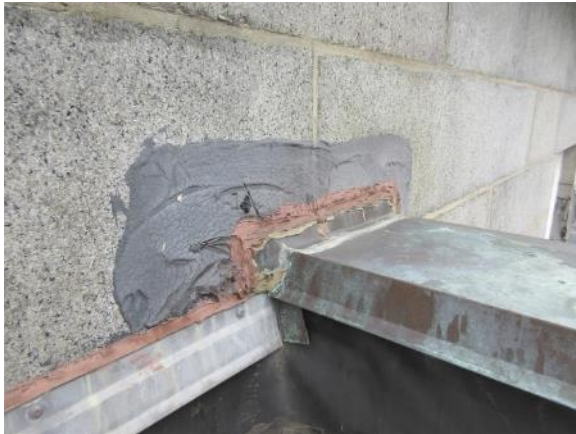
**Image 105:** Deficient termination of the parapet cap flashing on Roof Area C that is sealant-dependent

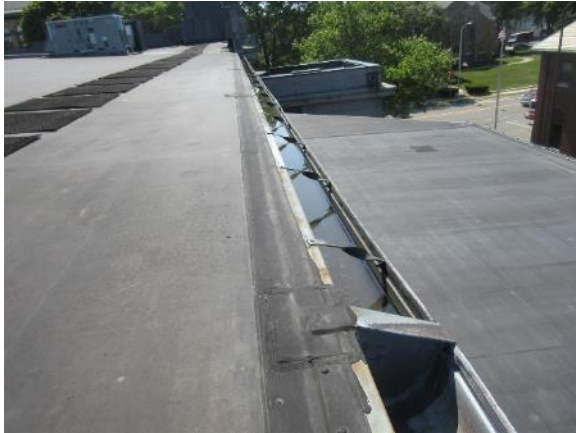
In general, gutters and downspouts were found to be in fair to poor condition. Many of the gutters feature open seams and failed gutter solder. Water was observed actively dripping from the gutter at joint locations. On the south side of Roof Area A, an existing roof access ladder mounted to the wood fascia has pulled away from the wall, displacing both the wood fascia and the attached gutter. Multiple downspouts have become detached from the gutter, and the gutter displacement prevents the water from draining properly towards the downspouts. Several downspouts at grade were observed to be dented or damaged resulting in misalignment of the downspout from their subgrade PVC leader, as well as detachment from their wall-mounted straps. Metal downspout strainers were generally found to be heavily deflected or displaced entirely from the downspout outlet.

**Image 107:** Standing water observed in the gutter on the south side of Roof Area A at the time of the evaluation

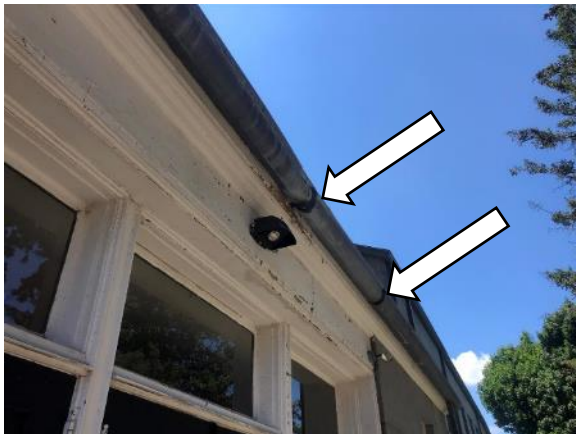
**Image 109:** Additional active gutter leak locations that have been attempted to be sealed with duct tape (arrows)

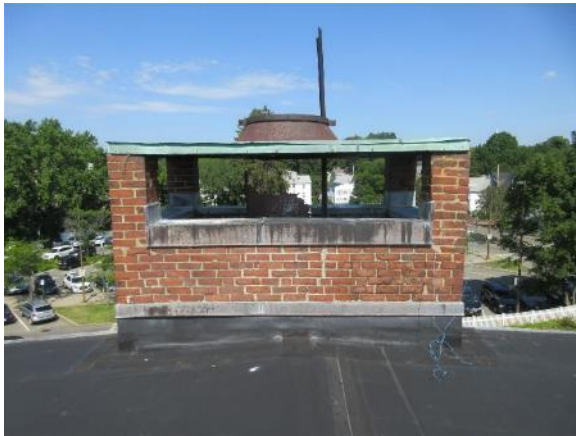
The condition of the chimney above the roof line is poor. While the wood deck itself appears to be sound, the brick masonry piers it rests on exhibit deteriorated mortar joints and a number of cracked brick masonry units throughout. Cracking of the mortar joints and brick units were also found in the chimney rising walls immediately above the roof. The copper cladding shows signs of heavy deterioration with deflection and pitting in the panels, exposed fastener holes, and failed sealant repairs at the seams on the top surface. The cast iron flue is rusted on all visible surfaces, with a large portion of the top section of the flue missing, appearing to originally extend up through the chimney cover. The lead-coated copper at the base of the chimney and capping the chimney walls appeared to be in good condition.

**Image 113:** Overall view of the chimney

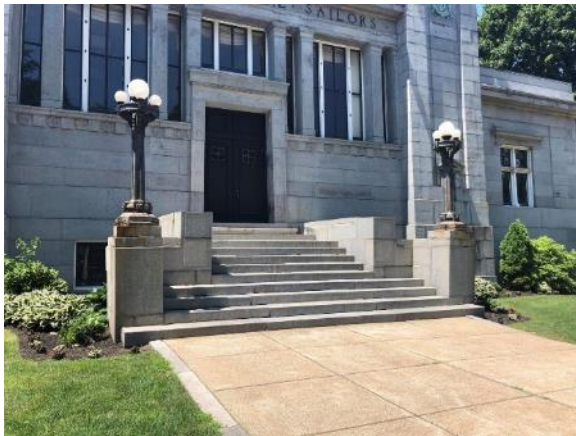
The front entrance is a prominent feature of the building and includes a large exterior grand staircase extending from the front entrance doorway down to the meet the entrance walkway. The staircase consists of a granite masonry construction, including granite stair treads and landings flanked by granite wing walls above grade, which rest on brick masonry infill and concrete foundation walls and piers below grade. According to original drawings, concrete beams rest on concrete piles and pile caps. At the front end of each wing wall sit decorative metal lampposts.

**Image 117:** Overall view of the front entrance stairs

2. Rebuilding of the granite front entrance stair with new piles and concrete foundation.

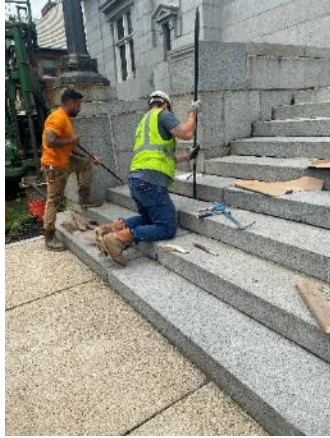
- One stair tread (4<sup>th</sup> from the bottom) was removed at the front left (facing the building) of the stairs.
- Excavated a 2'-0" deep hole dug at the north wing wall to determine foundation material.
- Portion of a grout patch was removed at the top landing joint where it meets the building.

**Image 119:** Location of stair removal

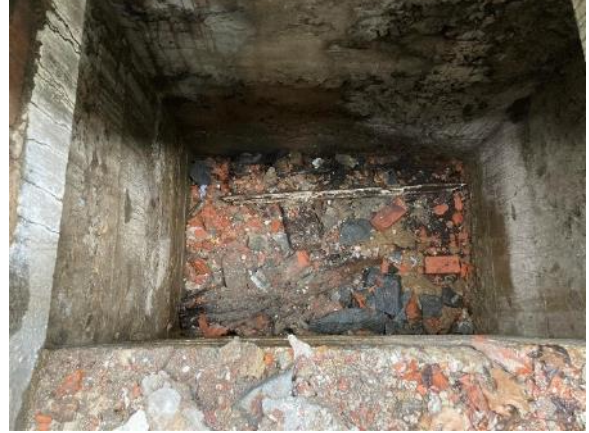
The exploratory work revealed that the interior of the stairs consists of a hollow cavity over nine feet deep. The bottom of the cavity is filled with masonry rubble and debris. Ground water was visible within the cavity at about 9'-4" depth from the removed stair tread. The center stair treads of the bottom four stairs are supported on brick piers. Several bricks were found to be loose upon removal of the stair tread. The brick mortar joints within the piers appeared to be loose and delaminated and were easily removed by hand.

**Image 120:** Removal of the stair revealed an open cavity below that is filled with rubble and debris.

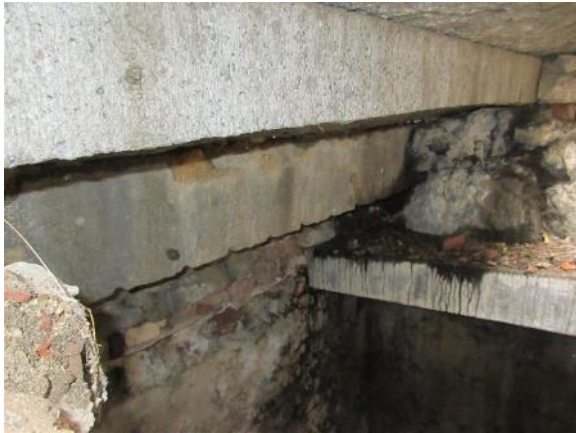
**Image 121:** View within the cavity looking towards the front of the stair. The foundation was found to be a combination of concrete stem walls, brick masonry, granite slabs, and rubble.

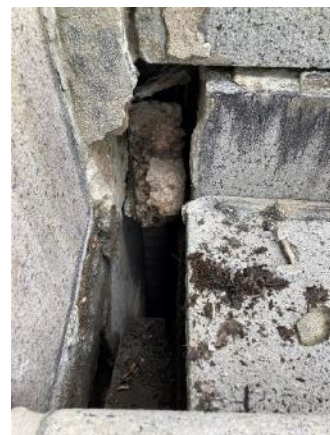
**Image 124:** The grout material was found to crumble upon sounding. A wood element was observed at this location and appeared to be displaced from its original position.

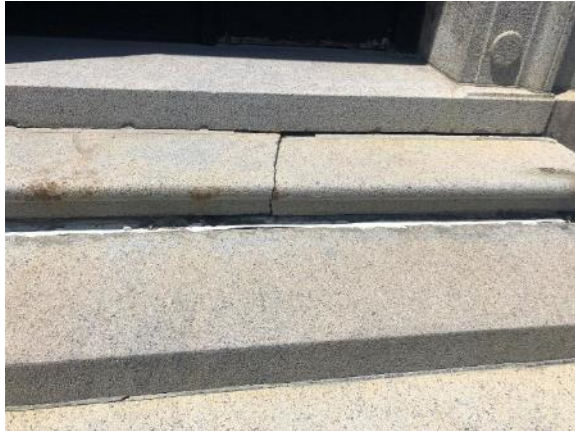
The front entrance stair was generally found to be in poor condition. While the majority of granite elements of the stair appeared to be in good condition, the top stair tread was found to have a crack running down the middle, and a majority of mortar joints are open, delaminated, or failed. Vegetation can be observed growing at isolated mortar joints on the wing walls. Portions of mortar joints between the stair treads are entirely missing. The wing walls appear to be out-of-plumb and leaning away from the building towards the street, as well as rotating outwards and away from the stair itself. Refer to the attached geotechnical report for more information. A large grouted joint was observed between the entrance stair and building's main elevation. The grouted joint appears to a previous repair attempt to address the stair rotation and settlement. The grouted joint runs along the wing walls and where the stair meets the building. Rust staining emanating from the base of the lampposts is visible on the granite blocks below. Dark staining and discoloration are visible at various other locations on the stair.

**Image 129:** A crack was found in the top-most stair tread in front of the door.

1. Repointing of failed granite and brick masonry joints, as well as all masonry joints located above roof areas.
2. Repair of crack and spalled granite masonry.
3. Replacement of cracked and spalled brick masonry units.
4. Installation of lead tees at sky-facing joints with the granite ledges.
5. Replacement of the expansion joints between the original building and the addition with pre-cured silicone and foam expansion joints.
6. Clean all exterior masonry surfaces.

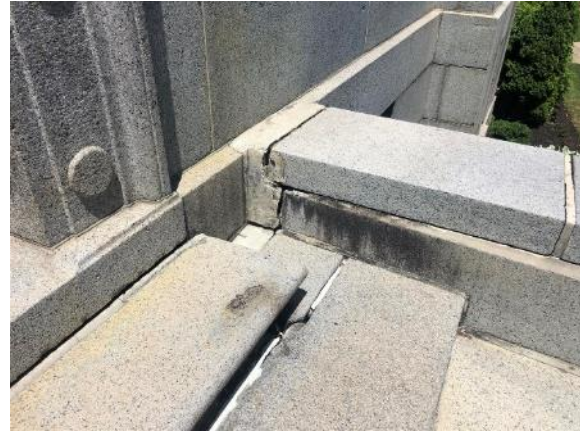
**Image 130:** Gaps observed in the joints between the stair structure and building.
