**CITY OF MELROSE**  
**APPROPRIATIONS & OVERSIGHT COMMITTEE**  
**AGENDA • MARCH 3, 2022**

Melrose has engaged Gale Associates, Inc. (Gale) to provide evaluation and design services to identify and address ongoing water infiltration at various locations in the building, improve daylight control within the auditorium clerestory windows, and general weathering and deterioration of various exterior building envelope components. As part of the evaluation, Gale has performed a leak audit, a visual observations of the building's exterior components and observed exploratory test cuts at roof, wall, and stair elements, performed by contractors, to better understand the general construction of the building. This evaluation report documents our observations, findings, and opinions on potential repair and replacement options.

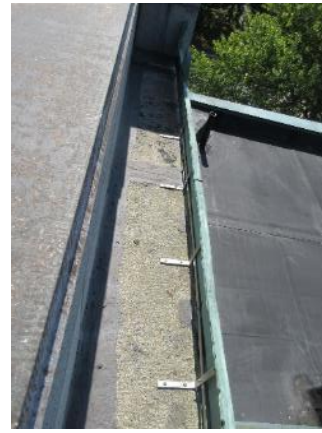
**Image 34:** Typical horizontal banding attachment straps.

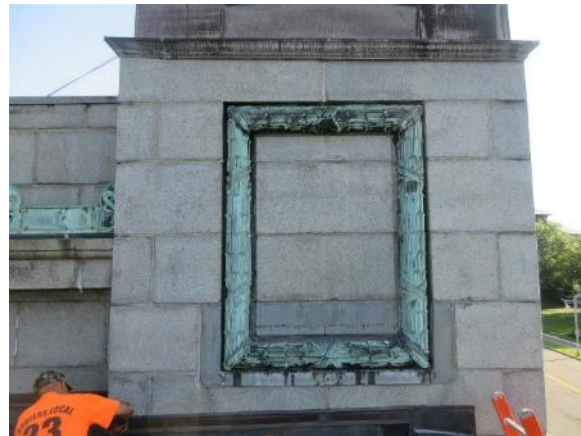
**Image 36:** Remaining brass garland ornament on the South Elevation. Similar ornament was installed on the Front (East) and North Elevations.

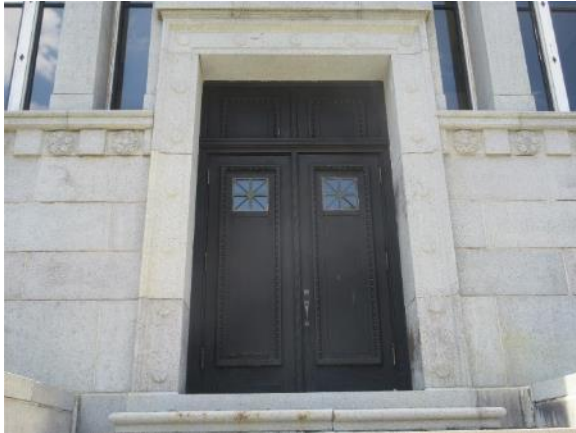
The front entrance door consists of wood frame and (1) set of wood double doors with a fixed wood panel transom above. This entrance appears to be primarily ceremonial, as the doors can only be operated from the interior with push bar hardware. The door frame and door leaves feature more elaborate ornamentation than other door locations, with egg and dart moulding, inset paneling, and spiral patterned astragal. Interior surfaces of the frames have a stained finish while the exterior surfaces are painted dark charcoal gray. The door handles and hinges consist of brass and appear to be in good condition. In general, the door frame and leaves appear to be in good condition, however, the exterior bottom portion of the door leaves are weathered, and one door sweep is missing. Minor paint defects could also be observed the exterior finish, related to the deterioration of some of the wood components.

**Image 61:** Exterior of the front entrance door

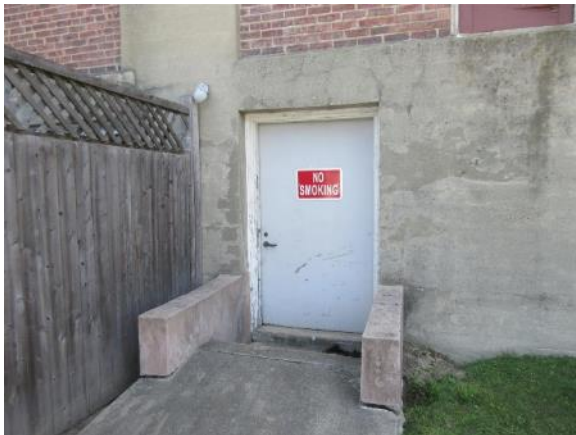
The rear of the building features a basement access door leading to the boiler room. The doorway consists of a hollow metal door set into a wood frame. The door leaf was found to be in good condition, similar to the hollow metal doors located at the sides of the auditorium. The wood trim around the door is exhibiting signs of minor deterioration and cracked and flaking paint throughout. The concrete door head appears to be slightly bowed, potentially related to the cracking occurring in the concrete above the door.

**Image 81:** Exterior of the basement door.

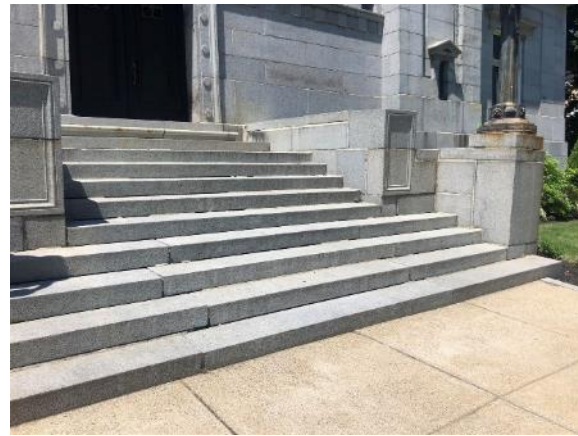
**Image 118:** Detail view of the front entrance stairs.
